Form Name: **IHCDA | BLN Pre-Bid Survey Results**  
Submission Date: Mar 23, 2018 8:03:20 AM EDT

Date of Survey: Mar 22, 2018  
Name of Surveyor: Greg Ubelhor  
Applicant Name: City of Evansville  
Property Address: 306 S Bosse Avenue, Evansville, IN 47712

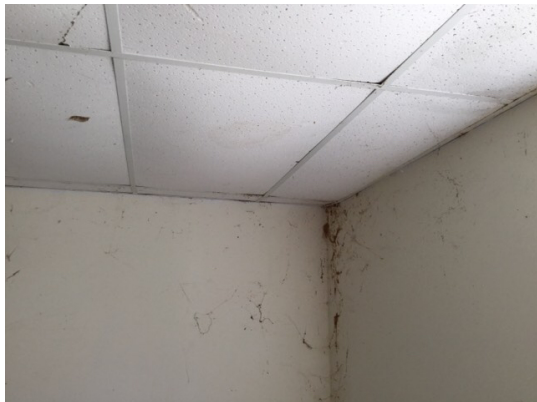
Multiple Rooms

POTENTIAL ASBESTOS-CONTAINING MATERIALS (ACM) Yes

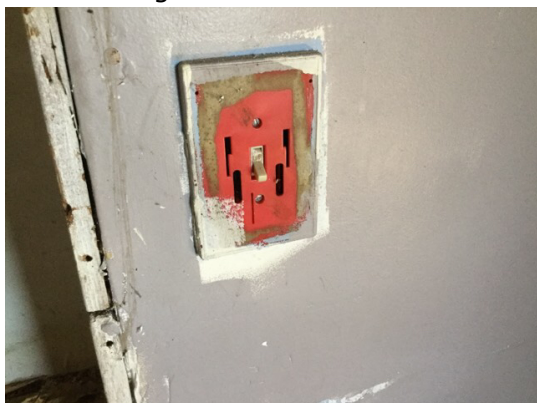
Multiple Rooms

Mercury light switches

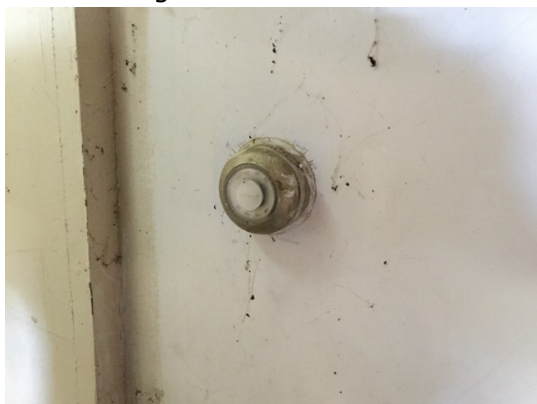
Hall

Mercury-containing thermostats

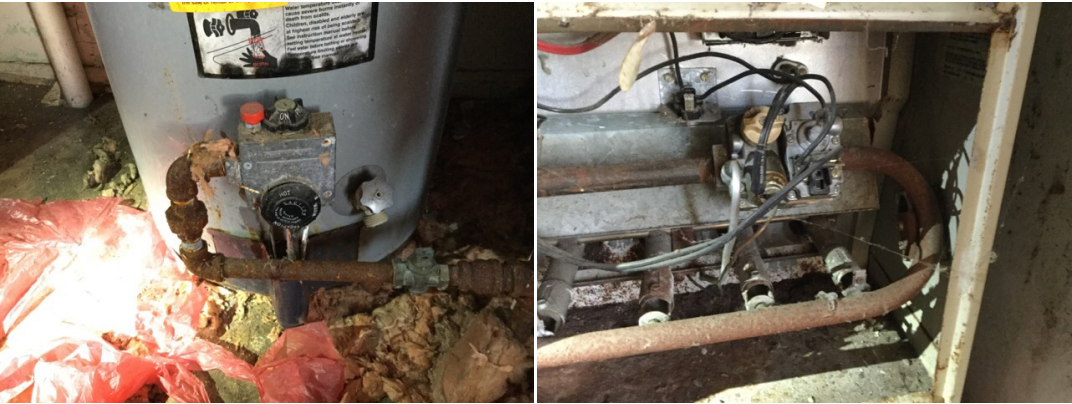
Utility room

Mercury-containing gas pressure regulators

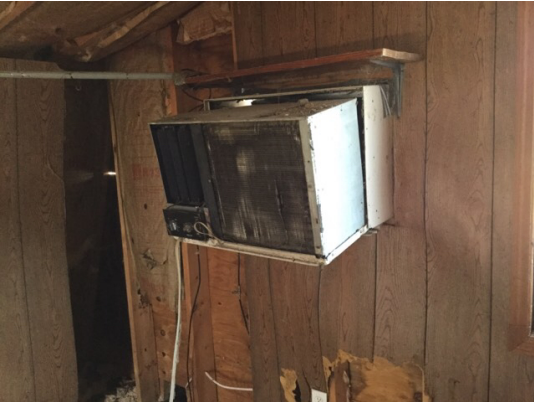
Batteries	No
Fluorescent, high-intensity discharge (HID), and low pressure sodium lamp bulbs	No
Refrigerant (found in air conditioners, refrigerators, freezers and dehumidifiers)	Yes
Room	Bedroom
Attach Image

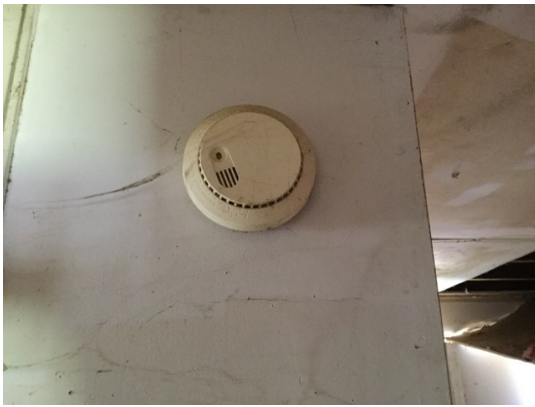
Smoke detectors	Yes
Room	Hall
Attach Image

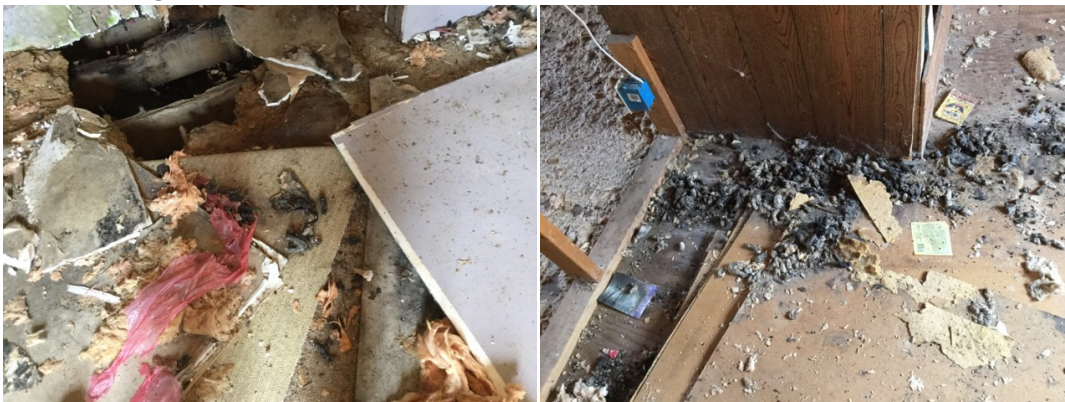
Biological waste (vermin, pigeon excrement) Yes  
Room Multiple Rooms  
Attach Image

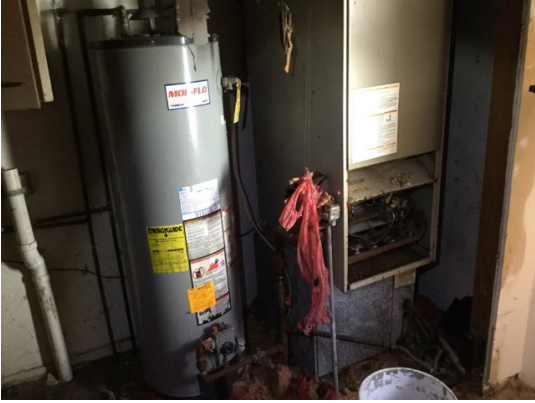
Mechanical equipment (lawn mowers, etc.)	No
Scrap tires	No
Major appliances	Yes
Room	Utility room
Attach Image
