Form Name: **IHCDA | BLN Pre-Bid Survey Results**
 Submission Date: Apr 22, 2019 12:26:27 PM EDT

Date of Survey Apr 22, 2019
 Name of Surveyor Larry McIntire
 Applicant Name City of Evansville
 Property Address 304 East Virginia Street, Evansville, Indiana 47711

Date of Survey Apr 22, 2019
 Name of Surveyor Larry McIntire
 Applicant Name City of Evansville
 Property Address 319 Read Street, Evansville, Indiana 47710

Date of Survey Apr 22, 2019
 Name of Surveyor Larry McIntire
 Applicant Name City of Evansville
 Property Address 701 North 10th Avenue, Evansville, Indiana 47712

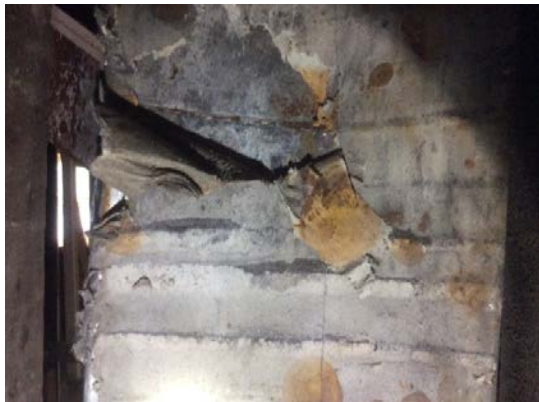
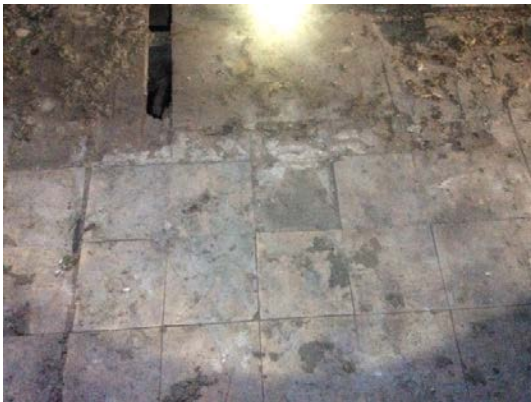
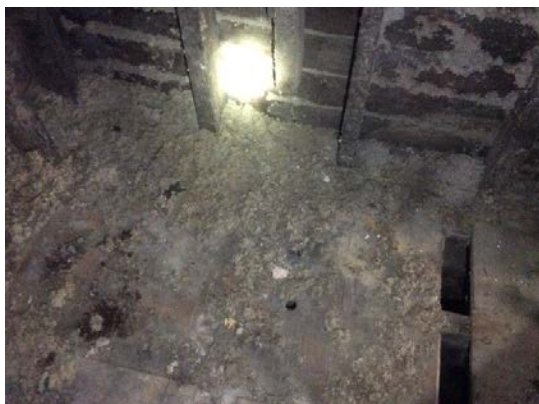
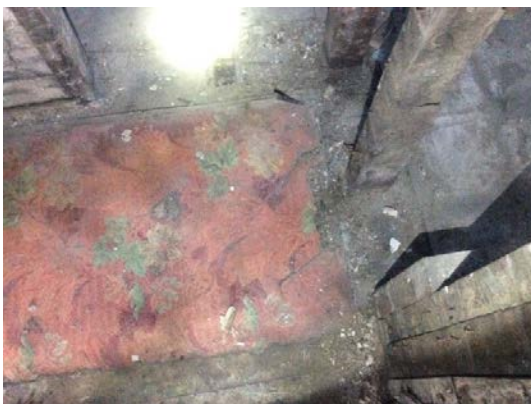
Kitchen

POTENTIAL ASBESTOS-CONTAINING MATERIALS (ACM) Yes

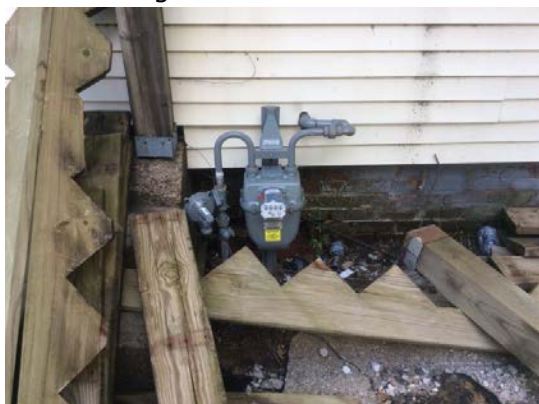
Exterior/Yard

Mercury-containing gas pressure regulators

Yes

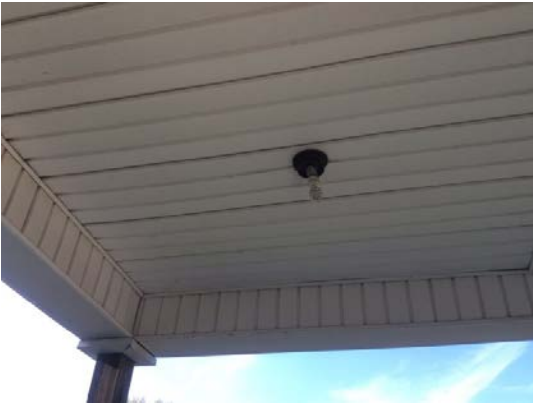
Exterior/Yard

Fluorescent, high-intensity discharge (HID), and low pressure sodium lamp bulbs

Yes

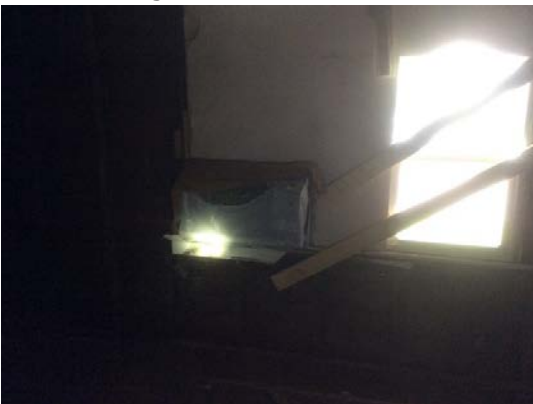
Living Room

Refrigerant (found in air conditioners, refrigerators, freezers and dehumidifiers)

Yes

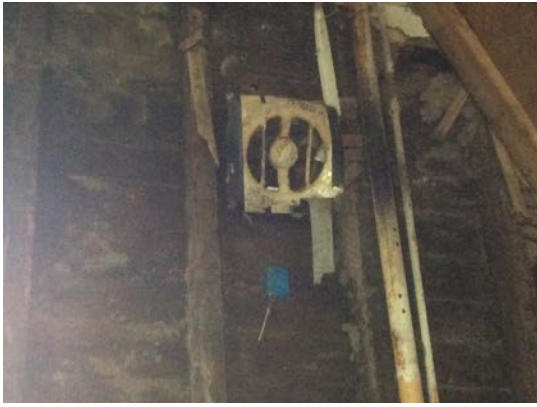
Kitchen

Electronics

Yes

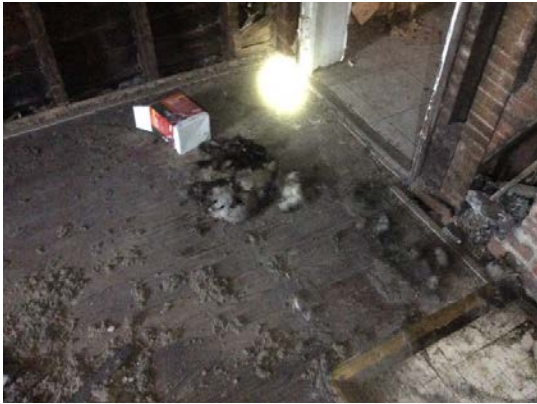
Chemicals	No
Pesticides	No
Paints	No
Solvents	No
Used oil	No
Fuels and fuel oil tanks	No
Biological waste (vermin, pigeon excrement)	Yes
Room	Living Room
Attach Image

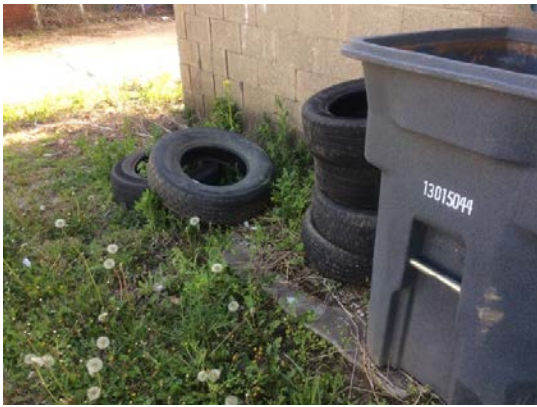
Medical waste (syringes)	No
Mechanical equipment (lawn mowers, etc.)	No
Scrap tires	Yes
Room	Exterior/Yard
Attach Image

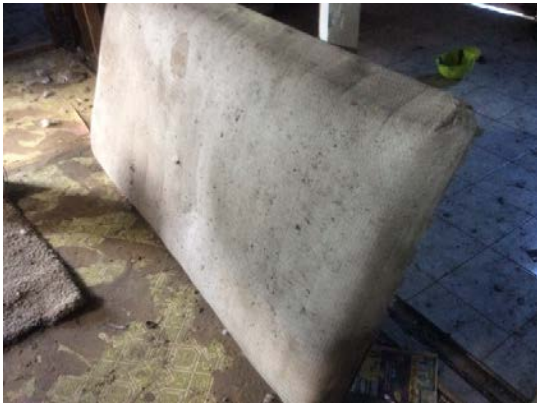
Major appliances	No
Furniture	No
Mattresses	Yes
Room	Living Room
Attach Image

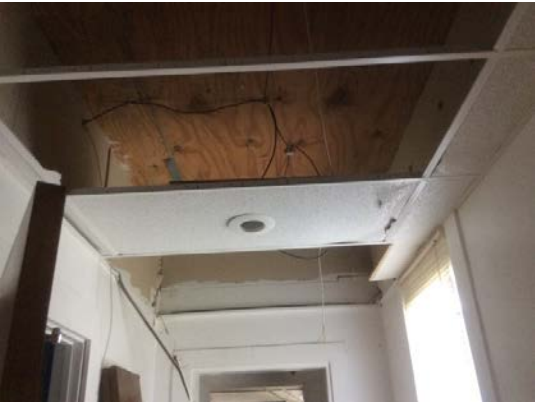
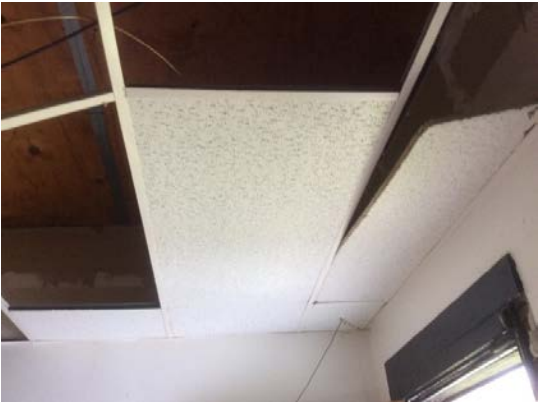
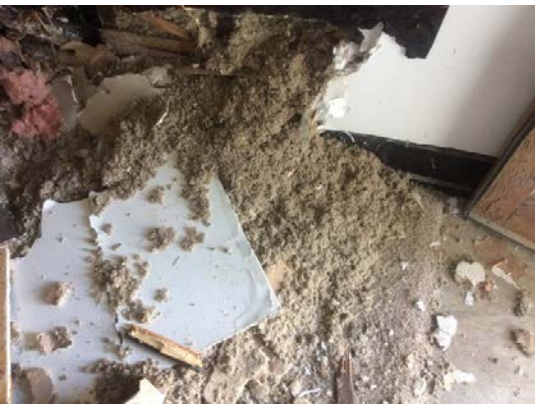
Multiple Rooms

POTENTIAL ASBESTOS-CONTAINING MATERIALS (ACM) Yes

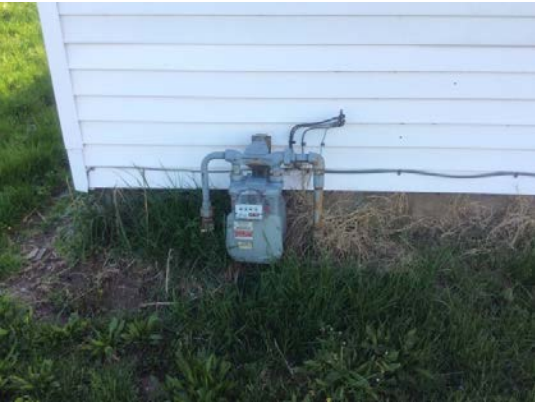
Exterior/Yard

POLYCHLORINATED BIPHENYLS (PCBs)	No
Mercury light switches	No
Mercury-containing thermostats	No
Mercury-containing gas pressure regulators	Yes

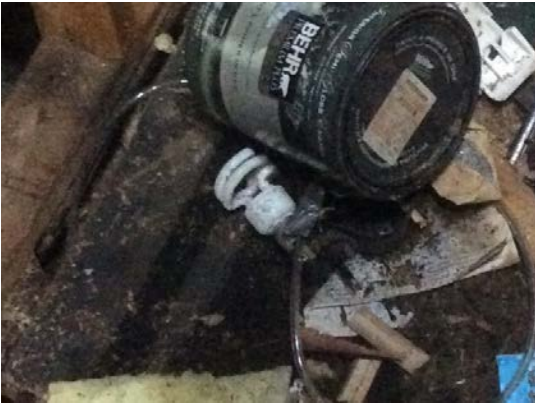
Bedroom

Fluorescent, high-intensity discharge (HID), and low pressure sodium lamp bulbs

Yes

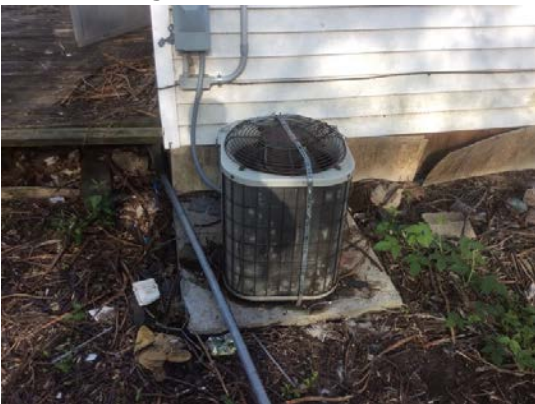
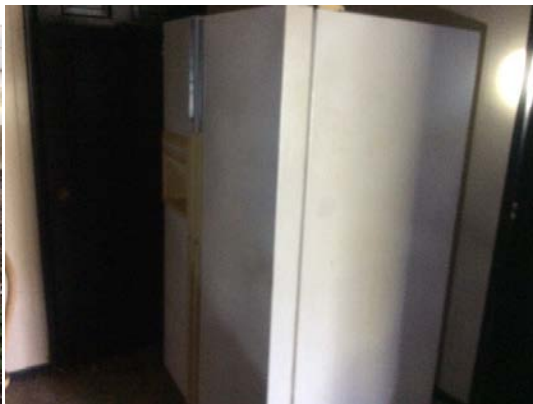
Multiple Rooms

Refrigerant (found in air conditioners, refrigerators, freezers and dehumidifiers)

Yes

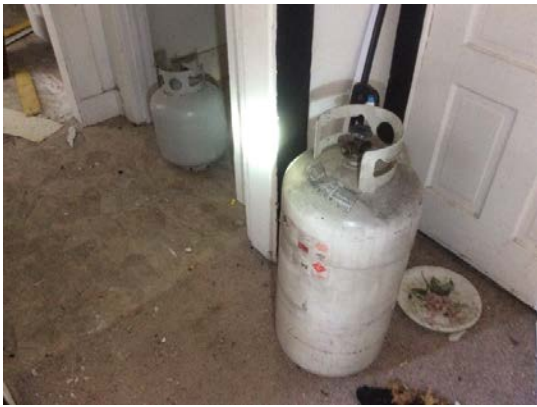
Living Room

Compressed gas cylinders

Yes

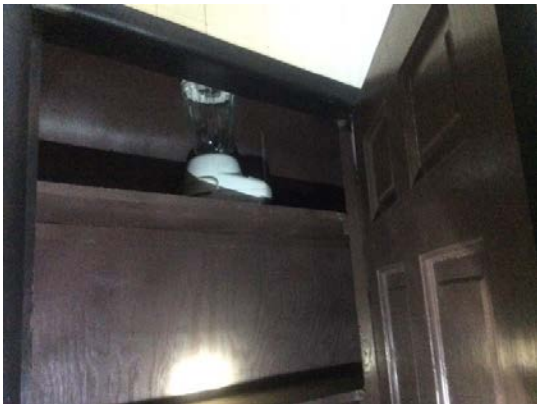
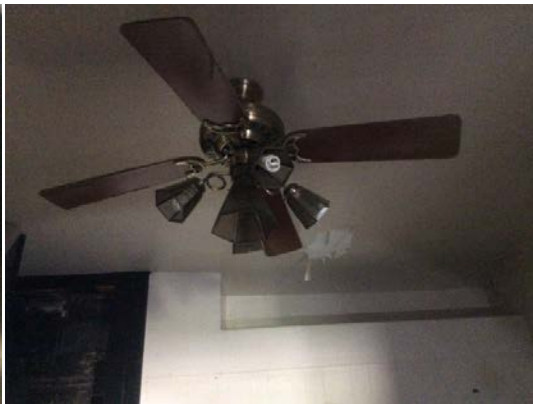
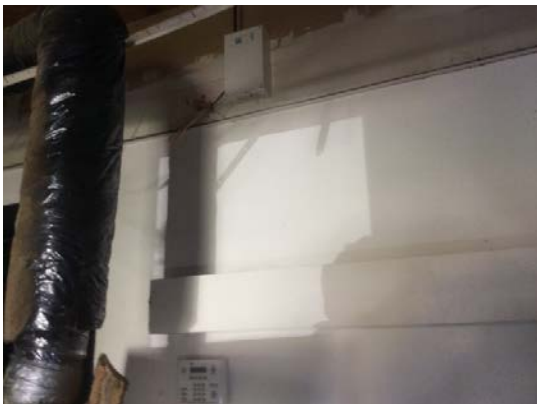
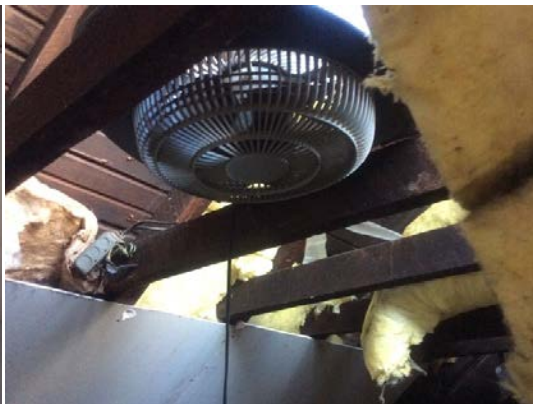
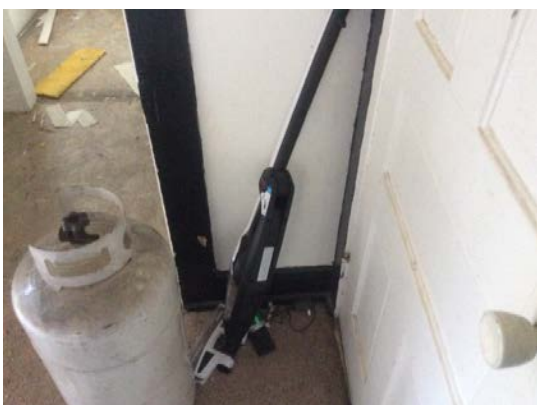
Multiple Rooms

Electronics

Yes

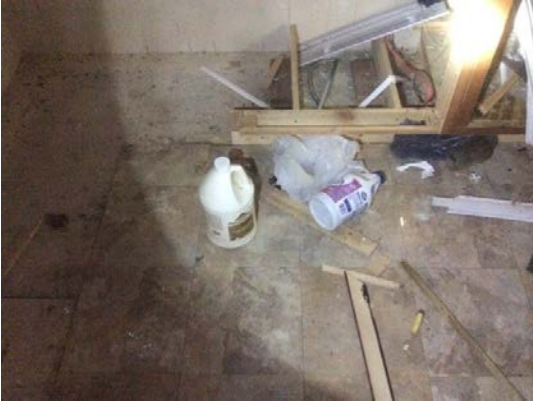
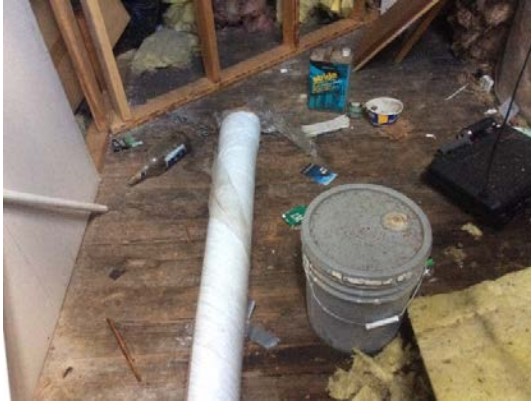
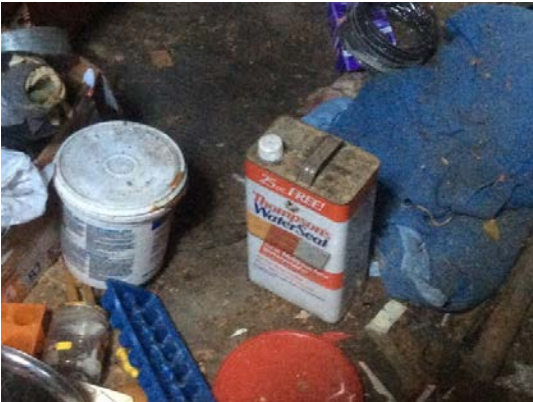
Chemicals
Room
Attach Image

Yes
Multiple Rooms

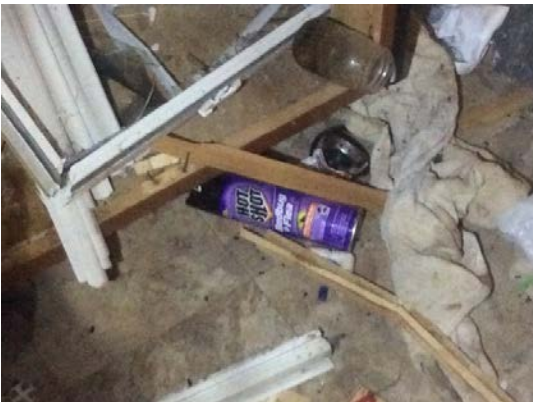
Pesticides
Room
Attach Image

Yes
Kitchen

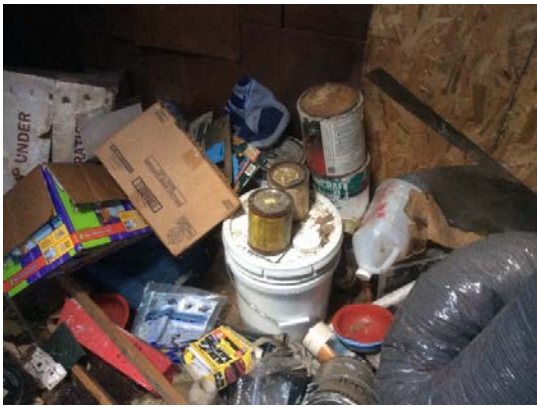
Paints
Room
Attach Image

Yes
Bedroom

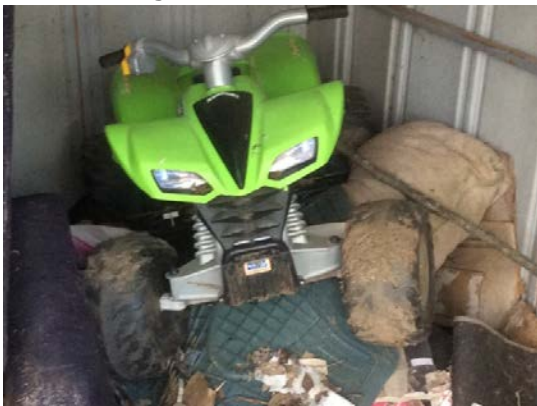
Solvents	No
Used oil	No
Fuels and fuel oil tanks	No
Biological waste (vermin, pigeon excrement)	No
Medical waste (syringes)	No
Mechanical equipment (lawn mowers, etc.)	Yes
Room	Exterior/Yard
Attach Image

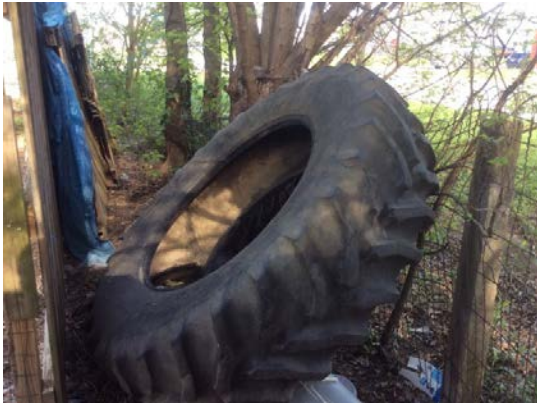
Scrap tires	Yes
Room	Exterior/Yard
Attach Image

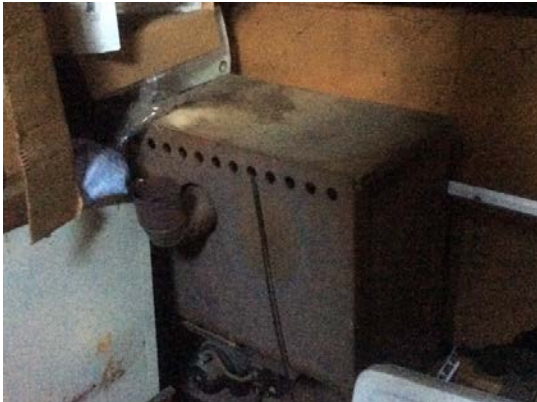
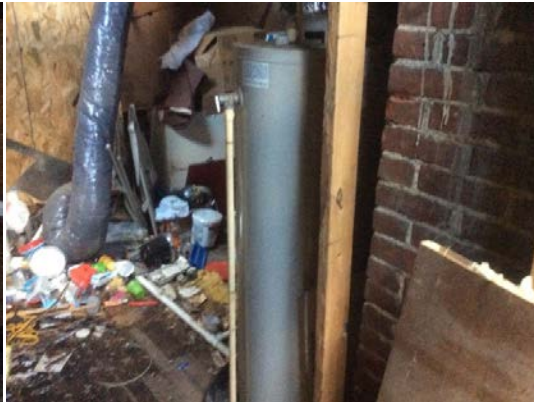
Bedroom

Major appliances

Yes

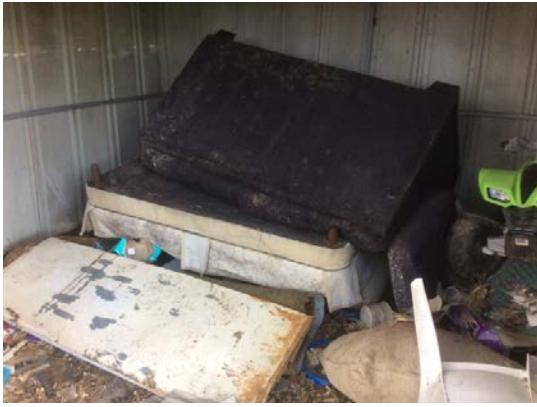
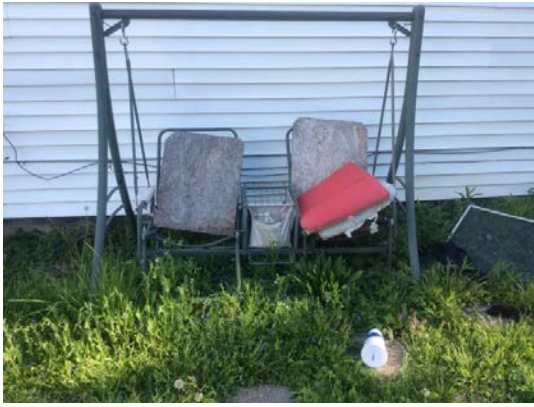
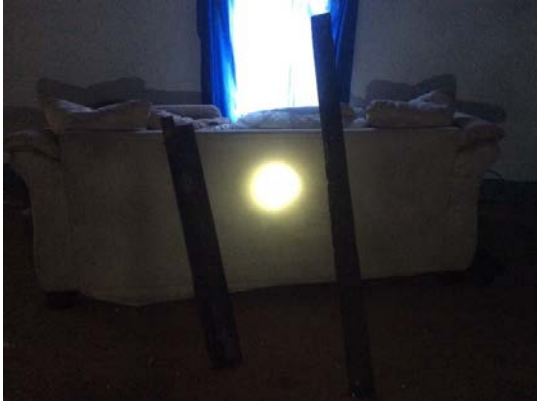
Multiple Rooms

Furniture

Yes

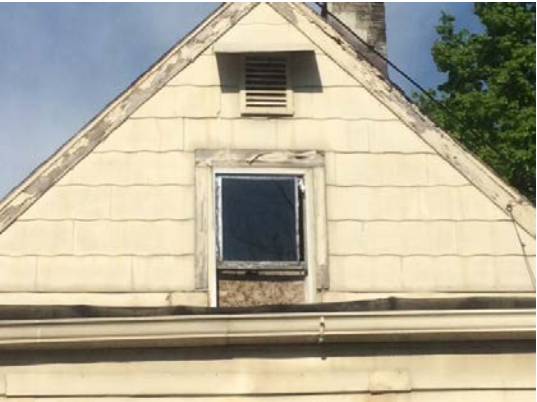
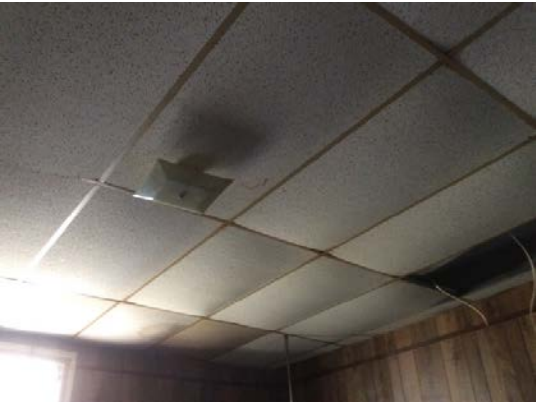
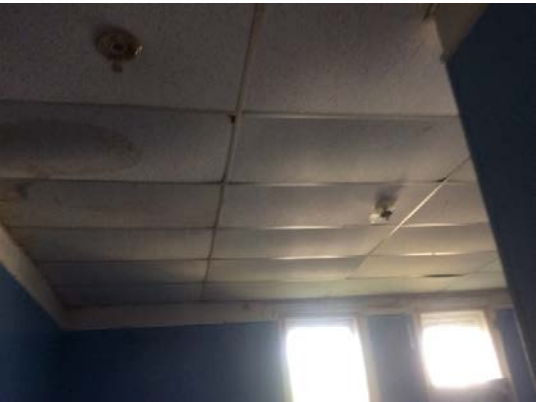
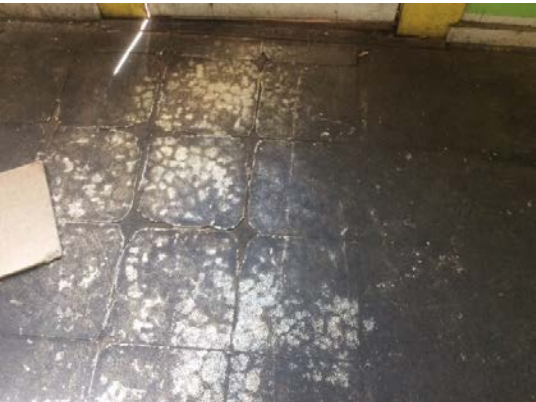
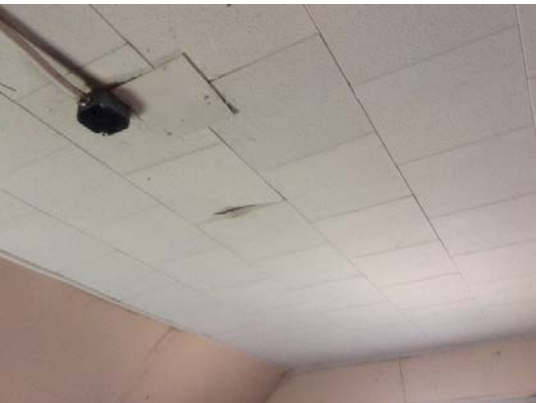
Multiple Rooms

POTENTIAL ASBESTOS-CONTAINING MATERIALS (ACM) Yes

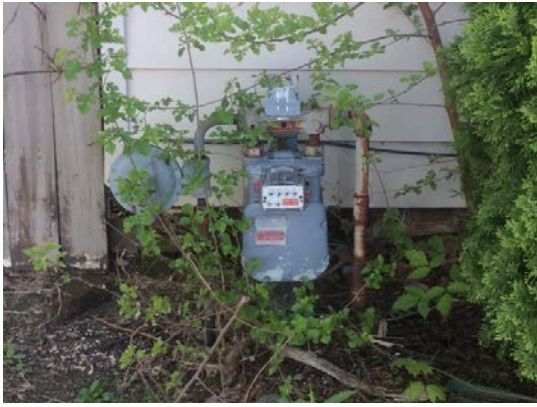
POLYCHLORINATED BIPHENYLS (PCBs)	No
Mercury light switches	No
Mercury-containing thermostats	No
Mercury-containing gas pressure regulators	Yes
Room	Exterior/Yard
Attach Image

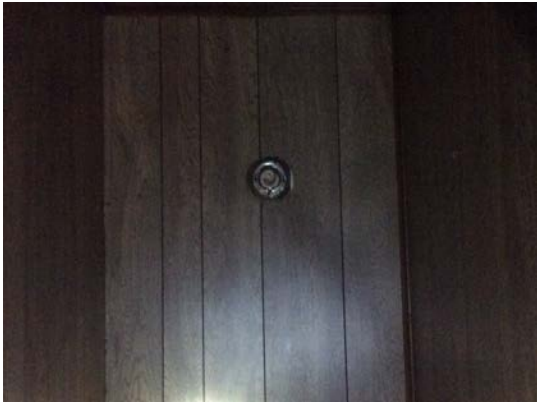
Room	Bedroom
------	---------

Fluorescent, high-intensity discharge (HID), and low pressure sodium lamp bulbs	Yes
---	-----

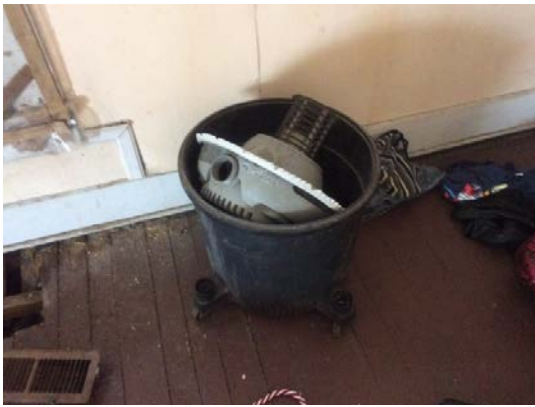
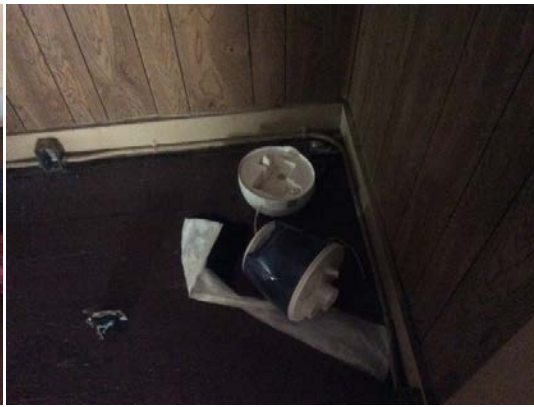
Room	Bedroom
------	---------

Electronics	Yes
-------------	-----

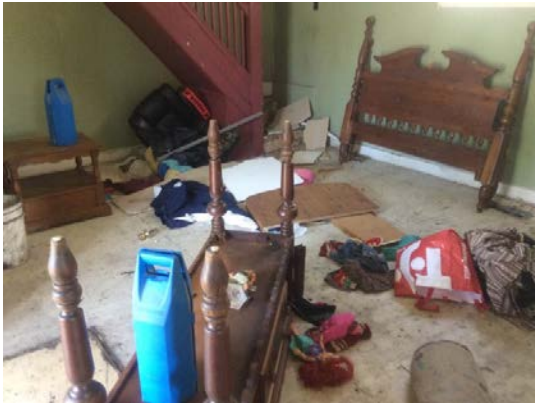
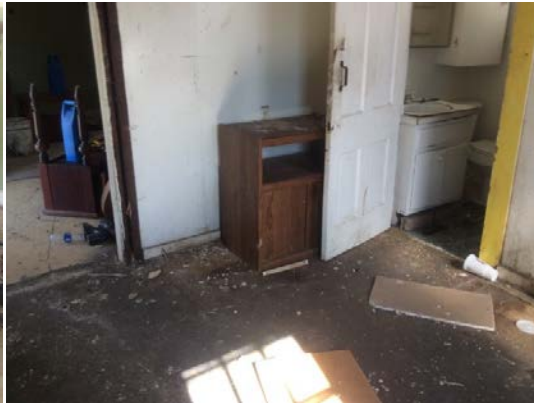
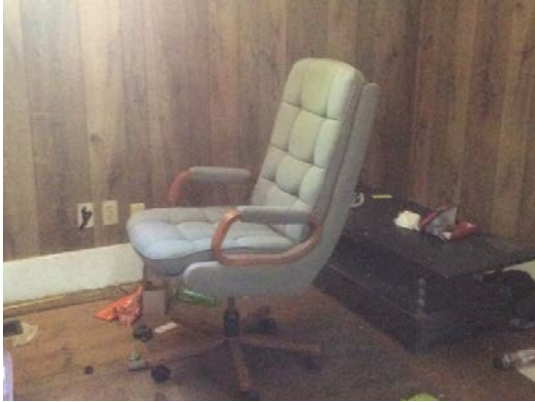
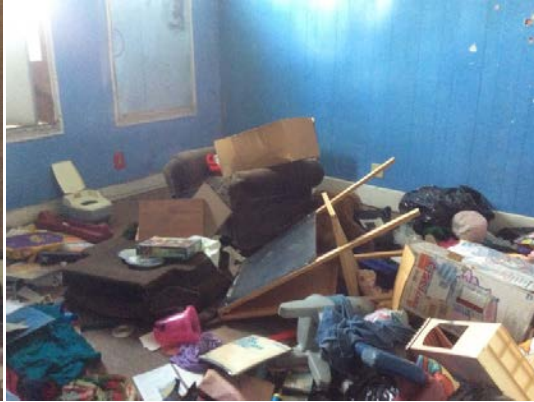
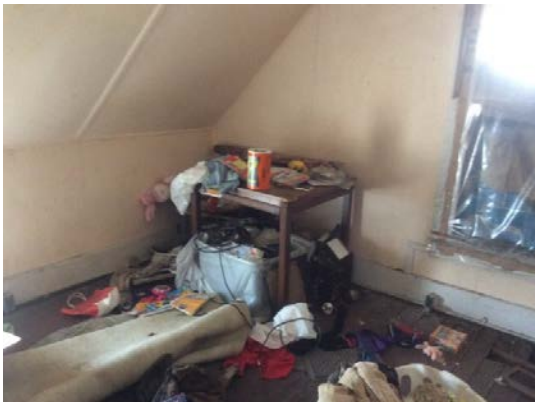
Chemicals	No
Pesticides	No
Paints	No
Solvents	No
Used oil	No
Fuels and fuel oil tanks	No
Biological waste (vermin, pigeon excrement)	No
Medical waste (syringes)	No
Mechanical equipment (lawn mowers, etc.)	No
Scrap tires	No
Major appliances	No
Furniture	Yes
Room	Multiple Rooms
Attach Image

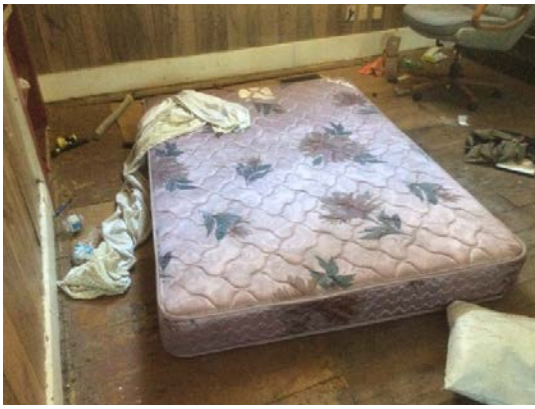
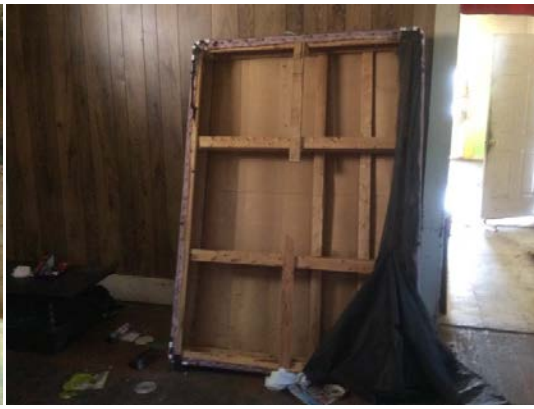
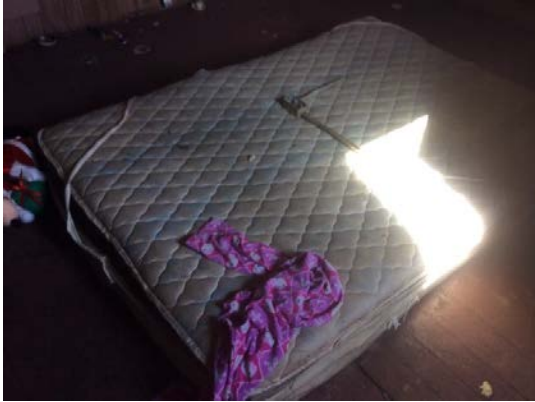
Mattresses
Room
Attach Image

Yes
Multiple Rooms
