Form Name: **IHCDA | BLN Pre-Bid Survey Results**
Submission Date: Mar 23, 2018 8:11:23 AM EDT

Date of Survey: Mar 22, 2018
Name of Surveyor: Greg Ubelhor
Applicant Name: City of Evansville
Property Address: 2528 W Franklin Street, Evansville, IN 47712

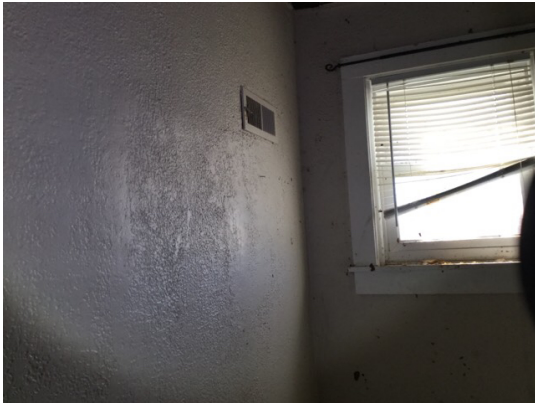
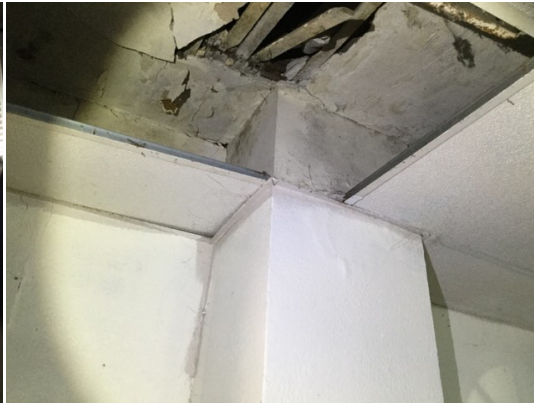
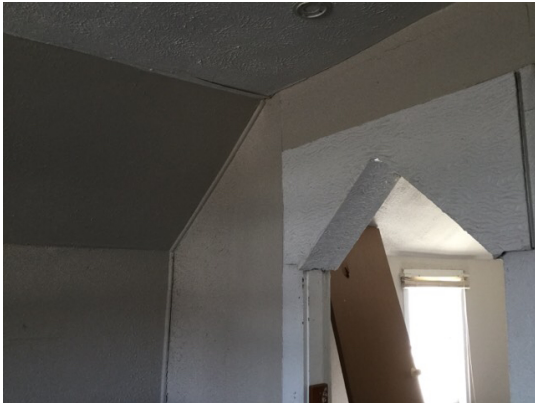
POTENTIAL ASBESTOS-CONTAINING MATERIALS (ACM) Yes
Room Multiple Rooms
Attach Image

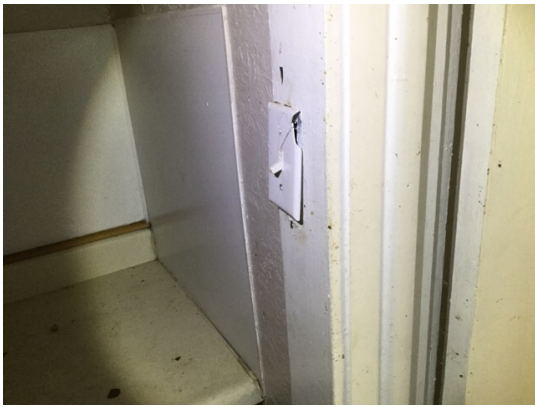
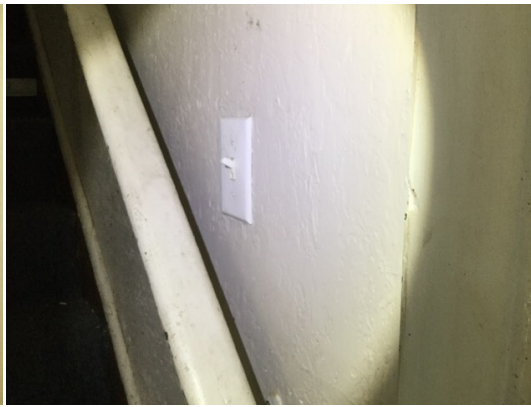
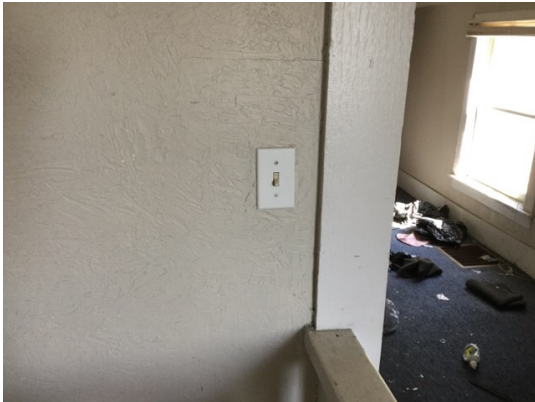
Mercury light switches

Yes

Multiple Rooms

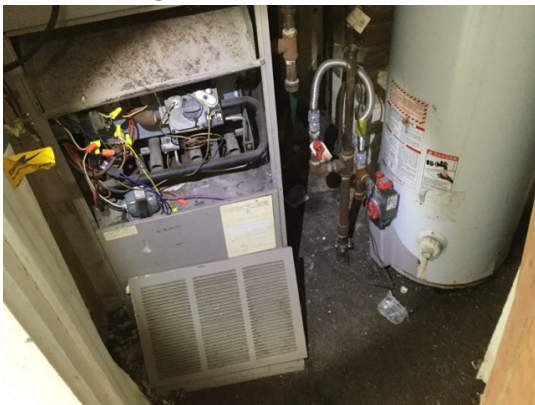
Mercury-containing gas pressure regulators	Yes
Room	Utility closet
Attach Image

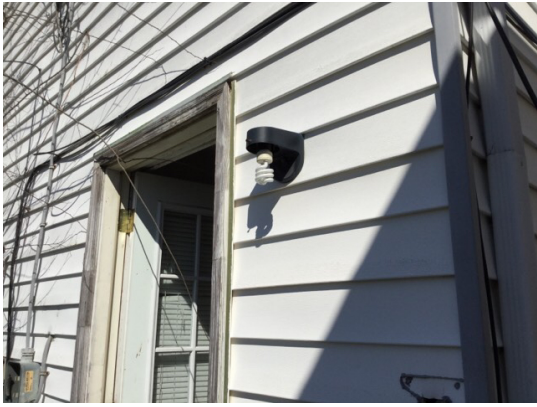
Fluorescent, high-intensity discharge (HID), and low pressure sodium lamp bulbs	Yes
Room	Exterior/Yard
Attach Image

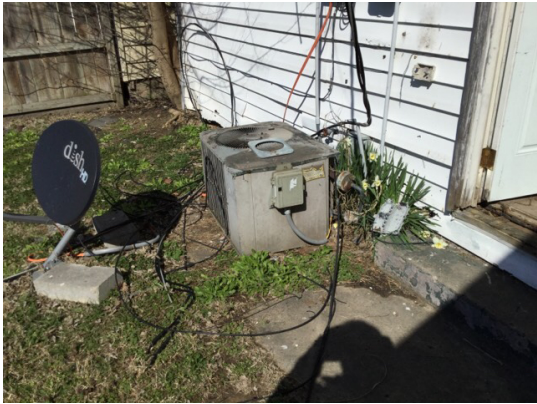
Refrigerant (found in air conditioners, refrigerators, freezers and dehumidifiers)

Exterior/Yard

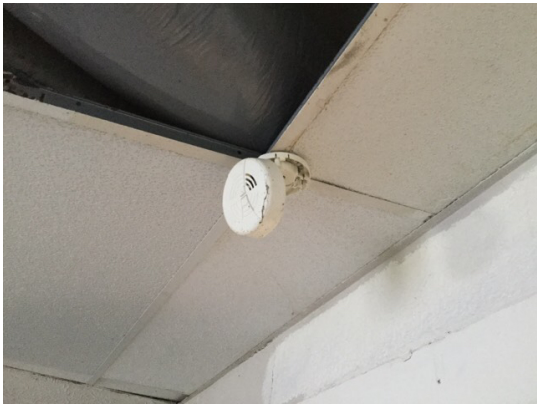
Smoke detectors

Living Room

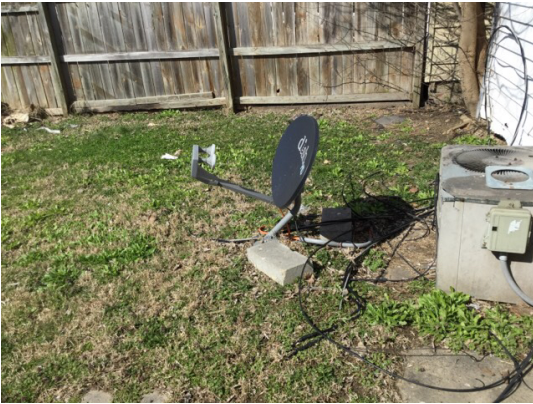
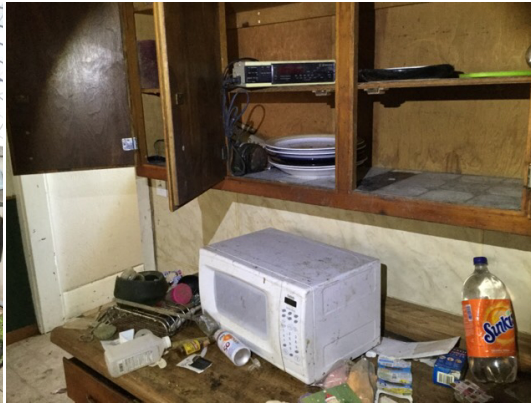
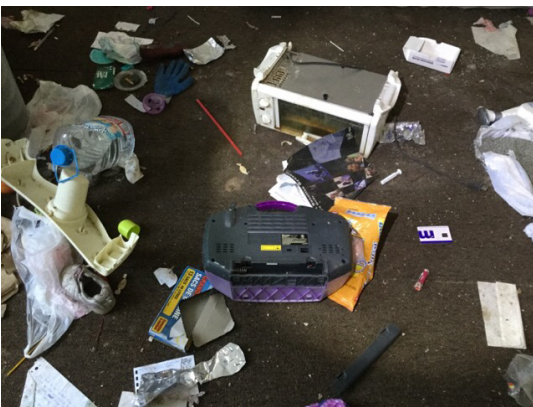
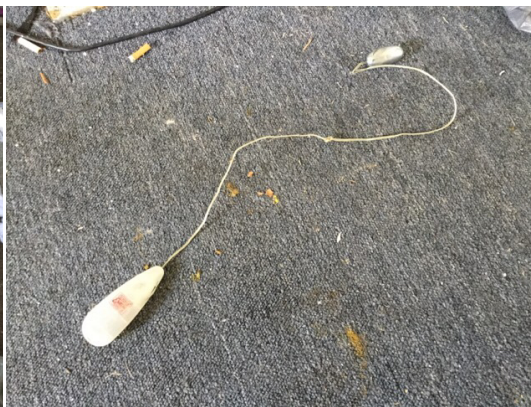
Electronics

Multiple Rooms

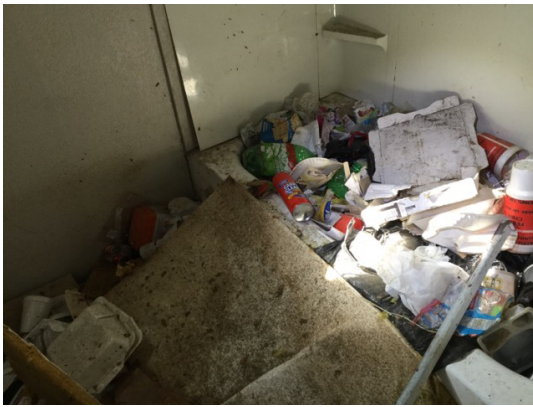
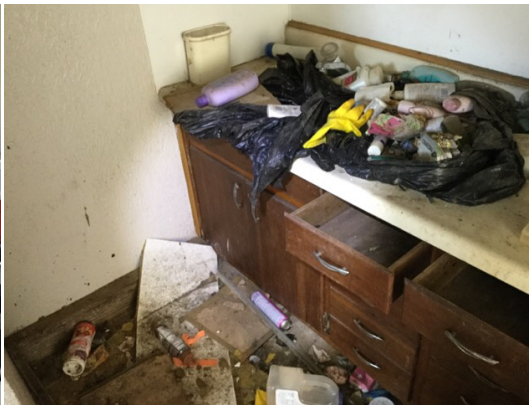
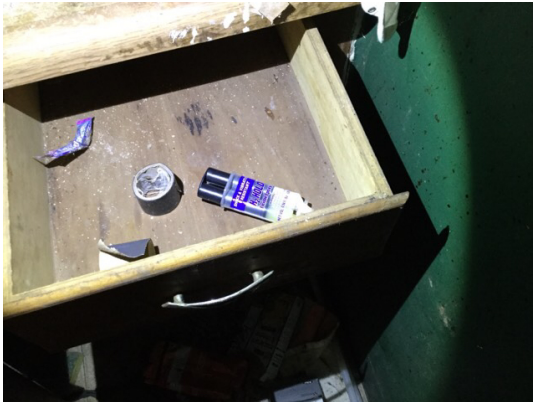
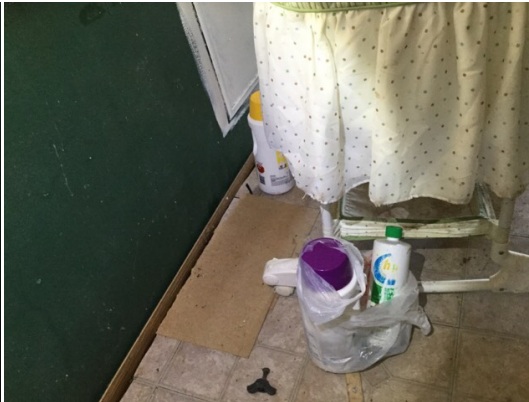
Chemicals

Multiple Rooms

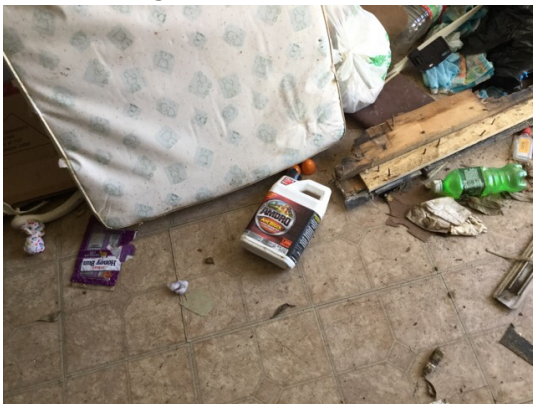
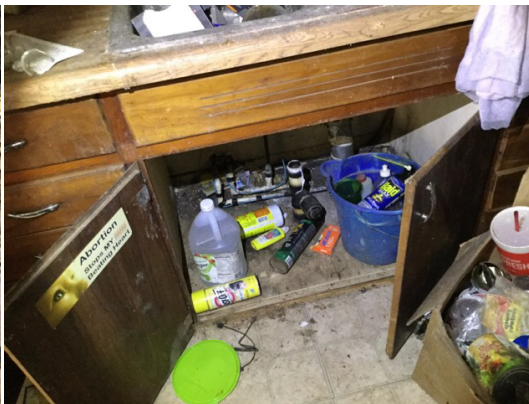
Pesticides

Multiple Rooms

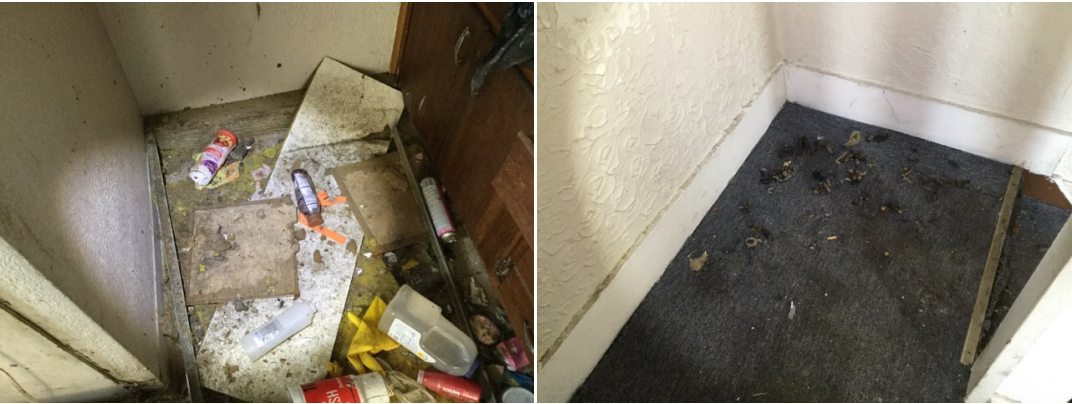
Biological waste (vermin, pigeon excrement)

Multiple Rooms

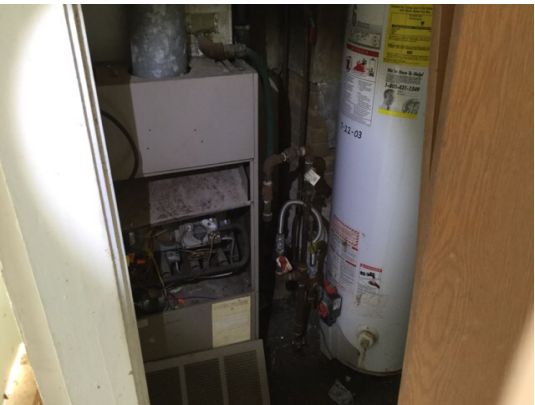
Medical waste (syringes)	No
Mechanical equipment (lawn mowers, etc.)	No
Scrap tires	No
Major appliances	Yes
Room	Utility closet

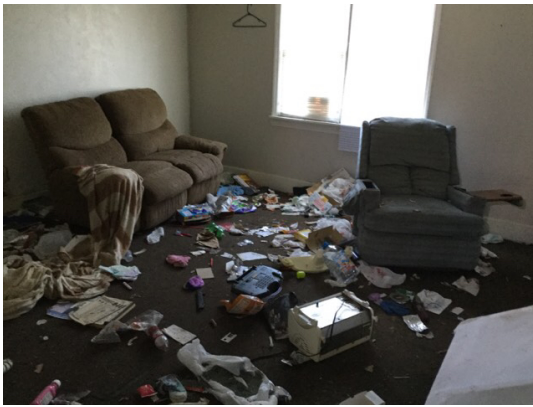
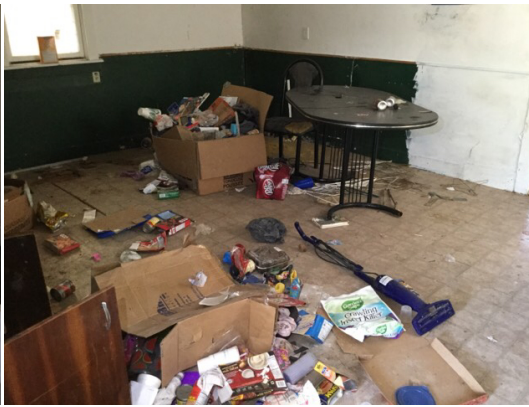
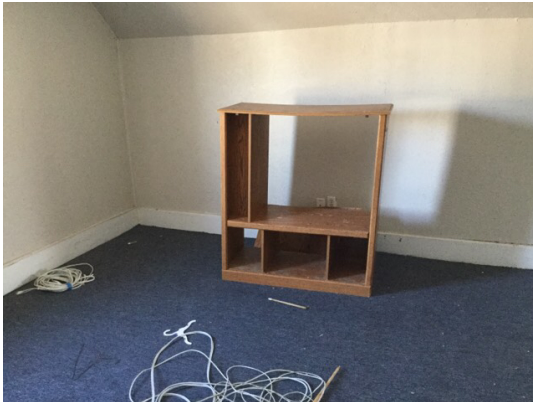
Furniture	Yes
Room	Multiple Rooms

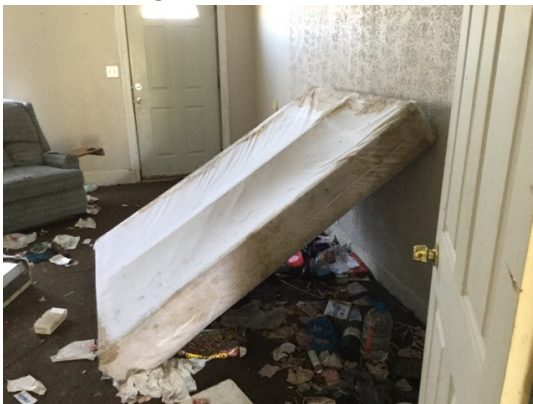
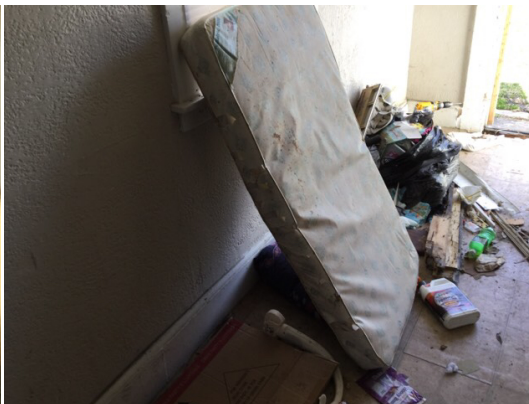
Mattresses

Multiple Rooms

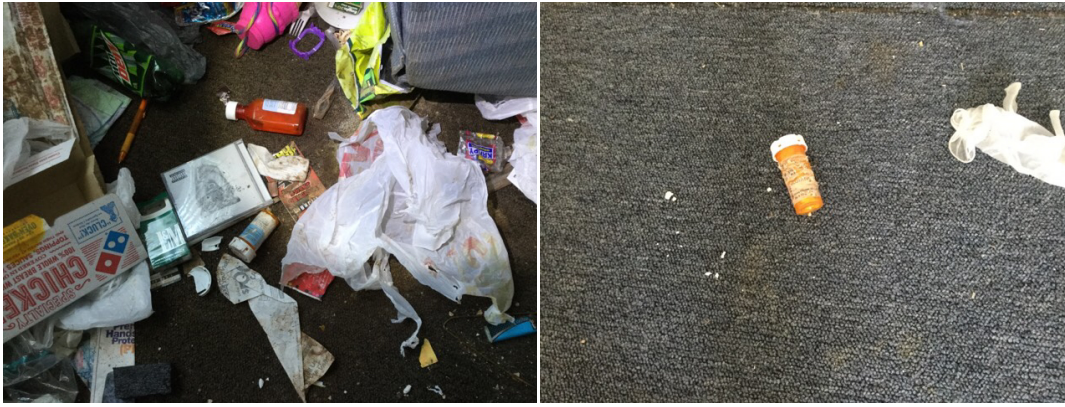
Controlled substances (pharmaceuticals or illegal substances)

Multiple Rooms
