RE: Asbestos Building Inspection for 1006 S. Barker Ave, Evansville, Indiana – Crane Project #118-2012

On April 5, 2018 Ellen Mullen of Crane Environmental Services, LLC conducted an Asbestos Building Inspection to determine if there was any Asbestos Containing Material (ACM) present at the subject property. The site is a one story vacant house which is scheduled to be demolished.

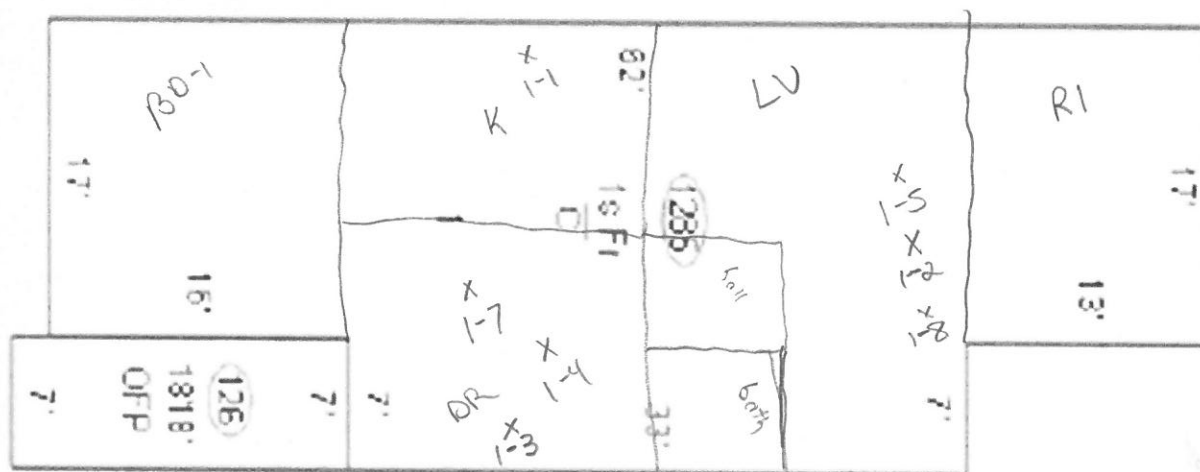
SAMPLING DIAGRAM

Sample #	Material	Location	% Asbestos
12-1-1	Hard Plaster Wall	Kitchen	ND
12-1-2	Hard Plaster Wall	Living Room	ND
12-1-3	Hard Plaster Wall	Dining Room	ND
12-1-4	Hard Plaster Ceiling	Dining Room	ND
12-1-5	Hard Plaster Ceiling	Living Room	ND
12-1-6	Hard Plaster Ceiling	Bedroom 1	ND
12-1-7	Ceiling Tile	Dining Room	ND
12-1-8	Duct Tape	Crawlspace	ND
12-Dup-1 (12-1-7)	Ceiling Tile	Dining Room	ND

First Floor

The RACM and Category I & II Non-Friable listed in the 3rd and 4th columns above need to be removed by an Indiana Licensed Abatement Contractor prior to demolition. The Non-Friable Category I & II ACM listed in the 5th column can remain on the substrate during demolition and disposed of in the landfill.
