RE: Asbestos Building Inspection for 306 Ridgeway Ave., Evansville, Indiana 47713 – Crane Project #120-0064

On May 28, 2020, Jarred Bannon of Crane Environmental Services, LLC conducted an Asbestos Building Inspection to determine if there was any Asbestos Containing Material (ACM) present at the subject property. The site is a one-story vacant house with a shed, which is scheduled to be demolished.

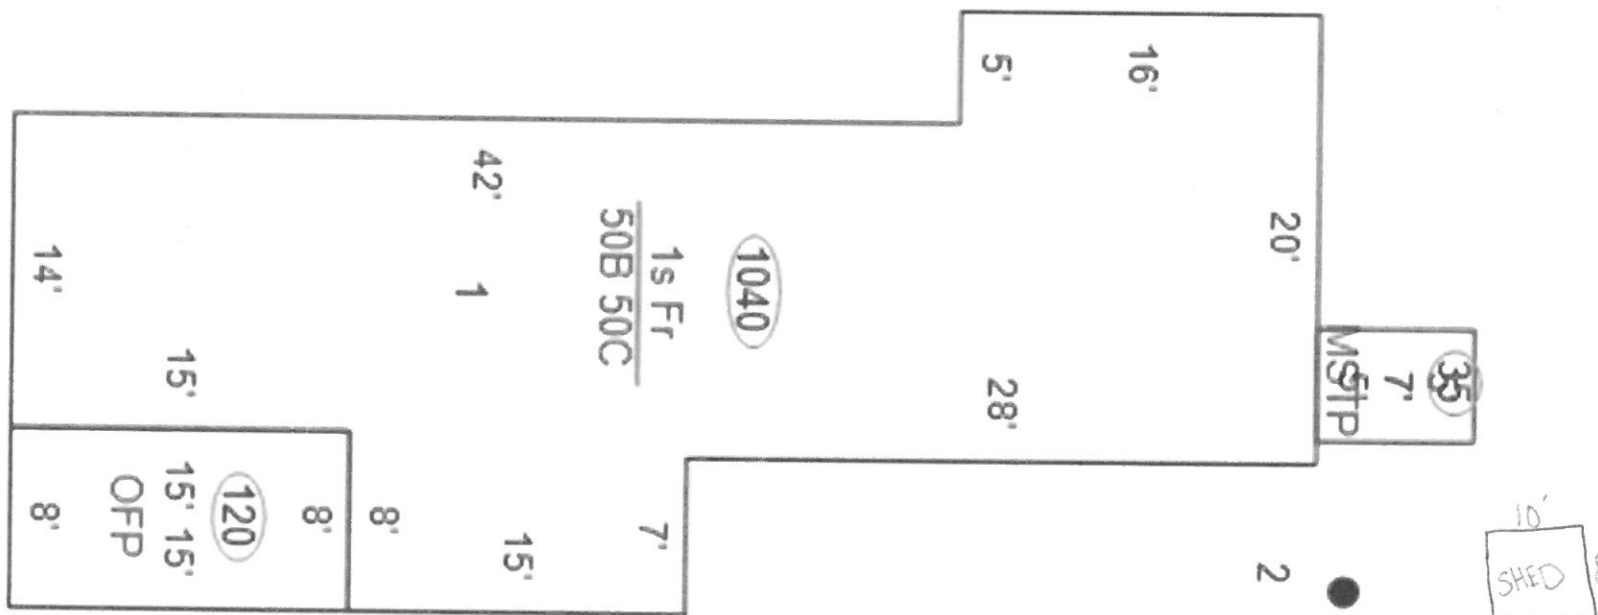
Basement: Yes No

2nd Floor: Finished Unfinished No
