211 Adams

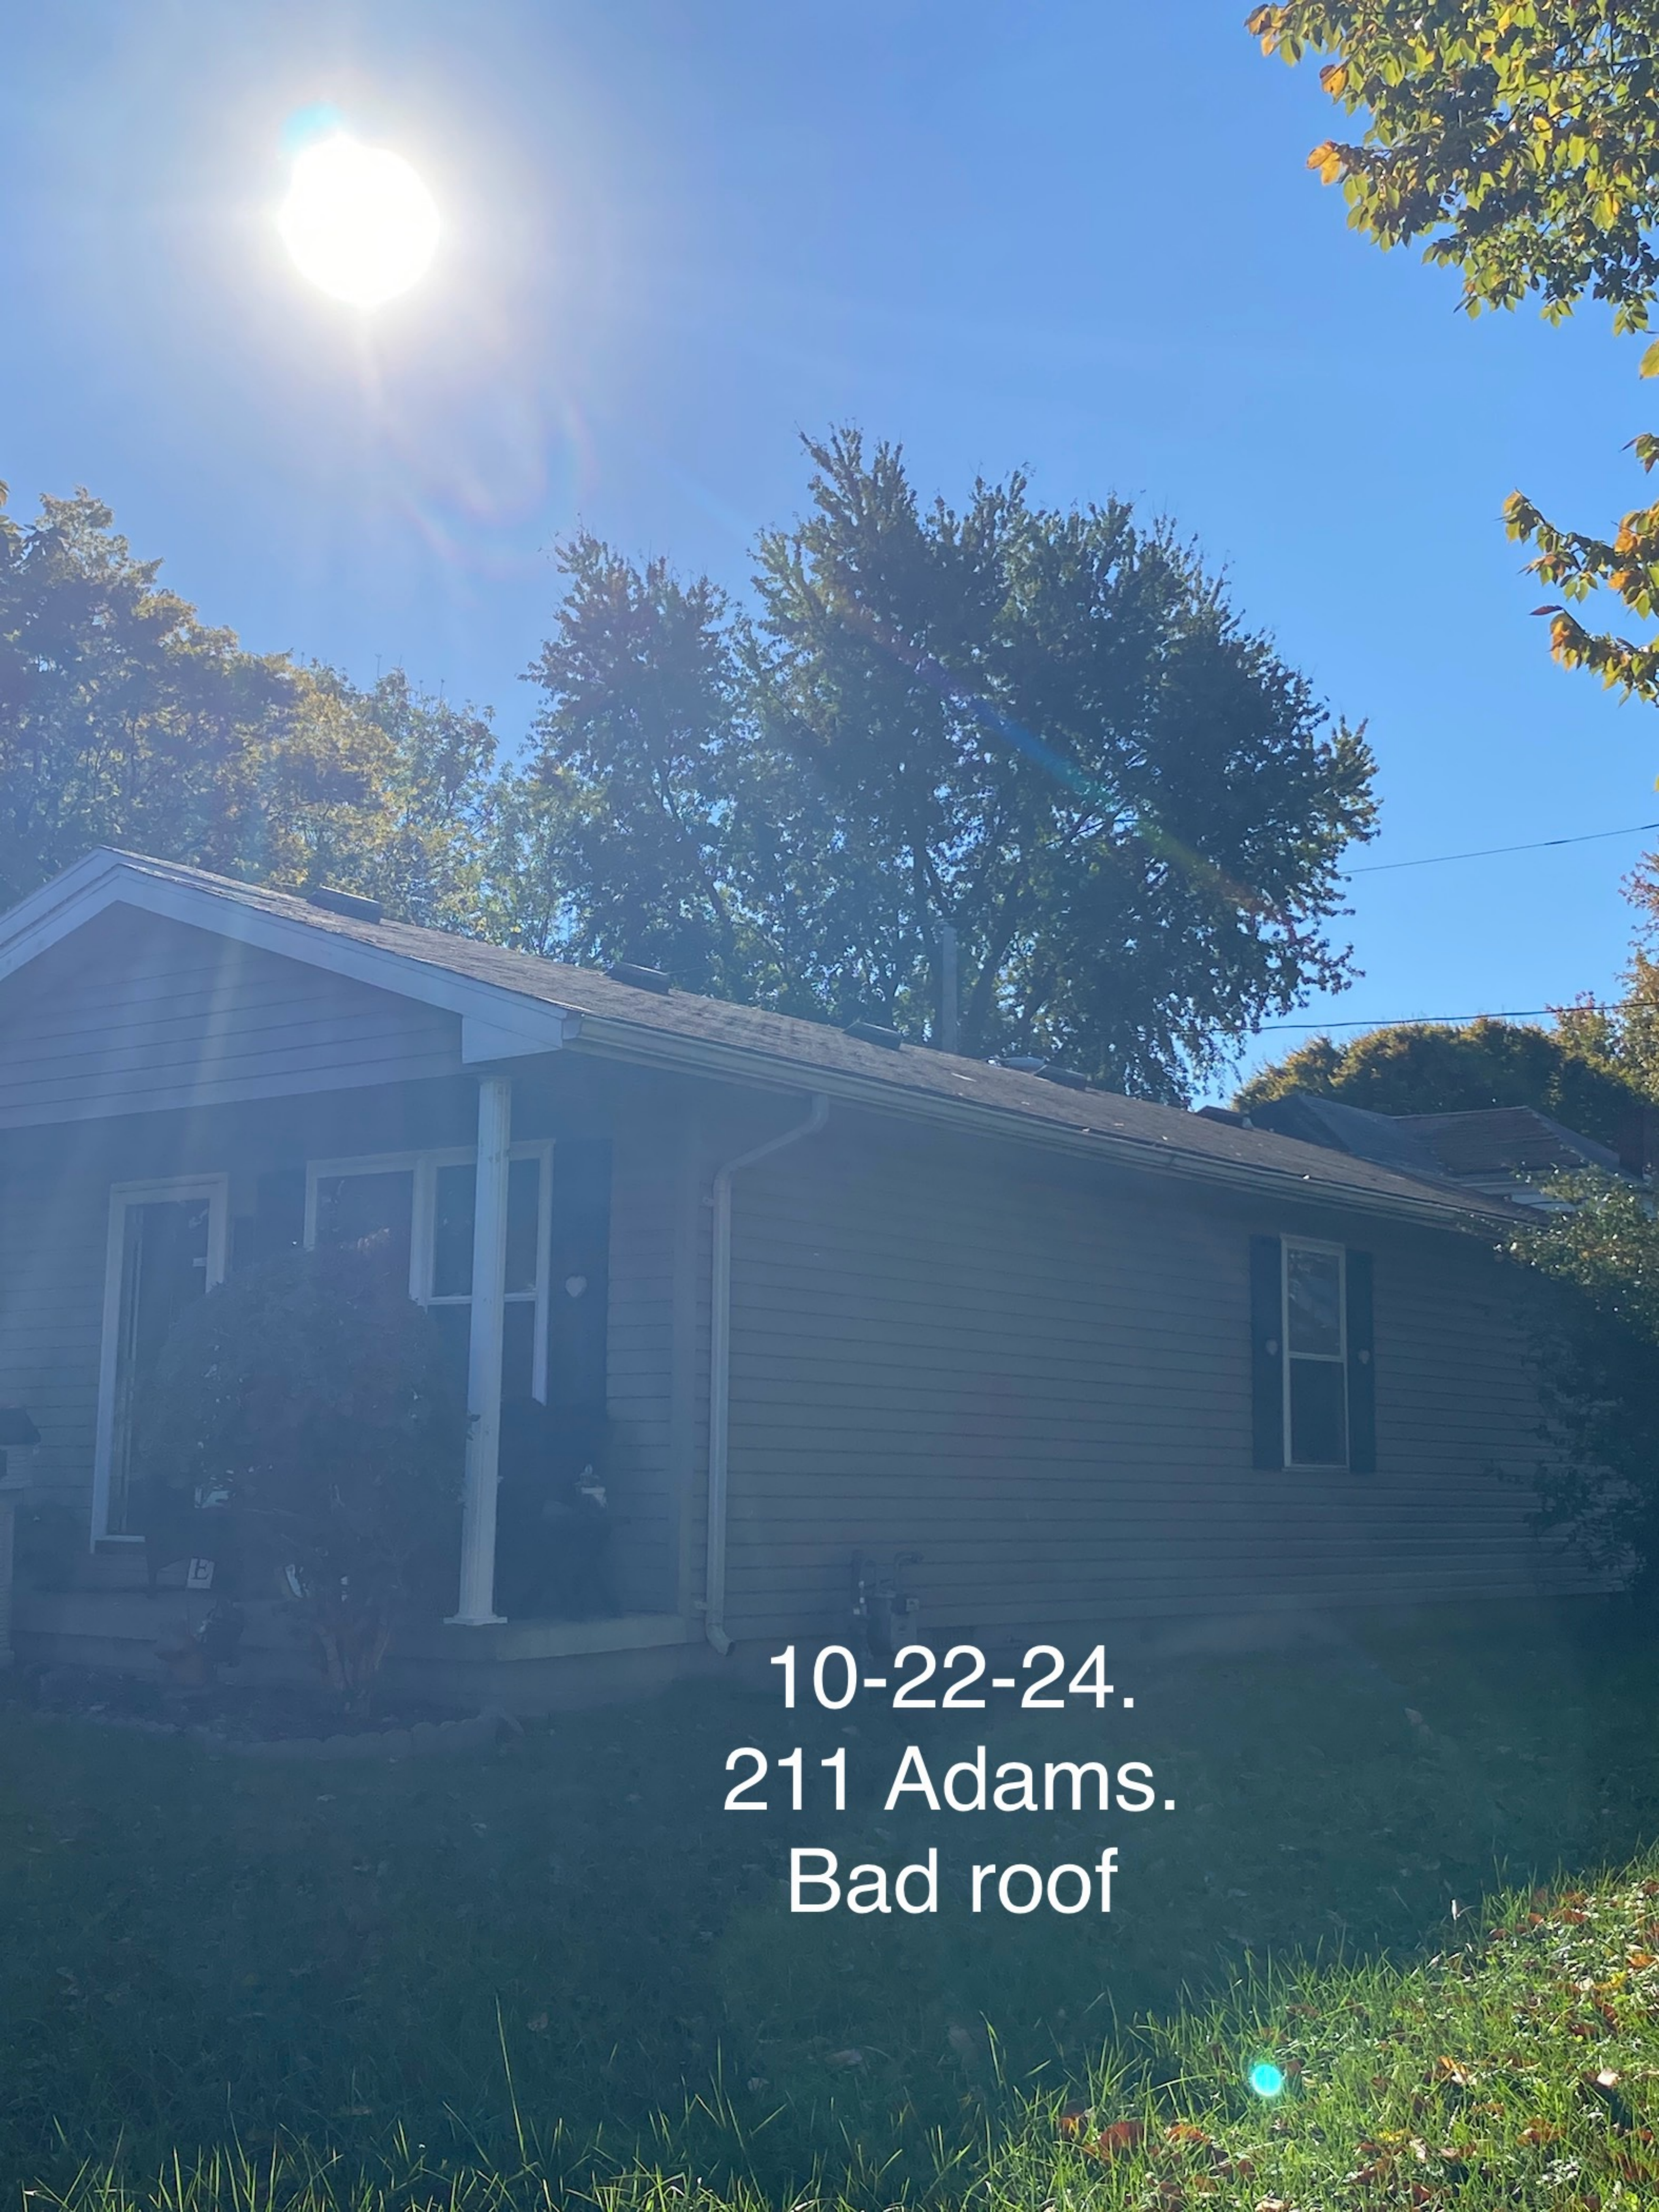
10-22-24.
211 Adams.
Bad roof

1. On all roof sections 3/12 pitch or greater, remove existing roof down to the decking. Protect the attic from debris. Any new decking shall match the existing. Any new framing shall be to code. Recover entire roof with the #20 felt paper and 25-year Tamko or equal asphalt seal down shingles. Install new metal starters, metal flashing, and counter flashing at all intersections and new plumbing vent boots. Install new "Cor-a-vent" ridge vent with ridge caps or approve equal. Assure the gutters and downspouts are clean and free from all debris. Assure area around the home is free from debris as possible when complete. Owner to choose in stock roof color. Provide all necessary material to complete this work.

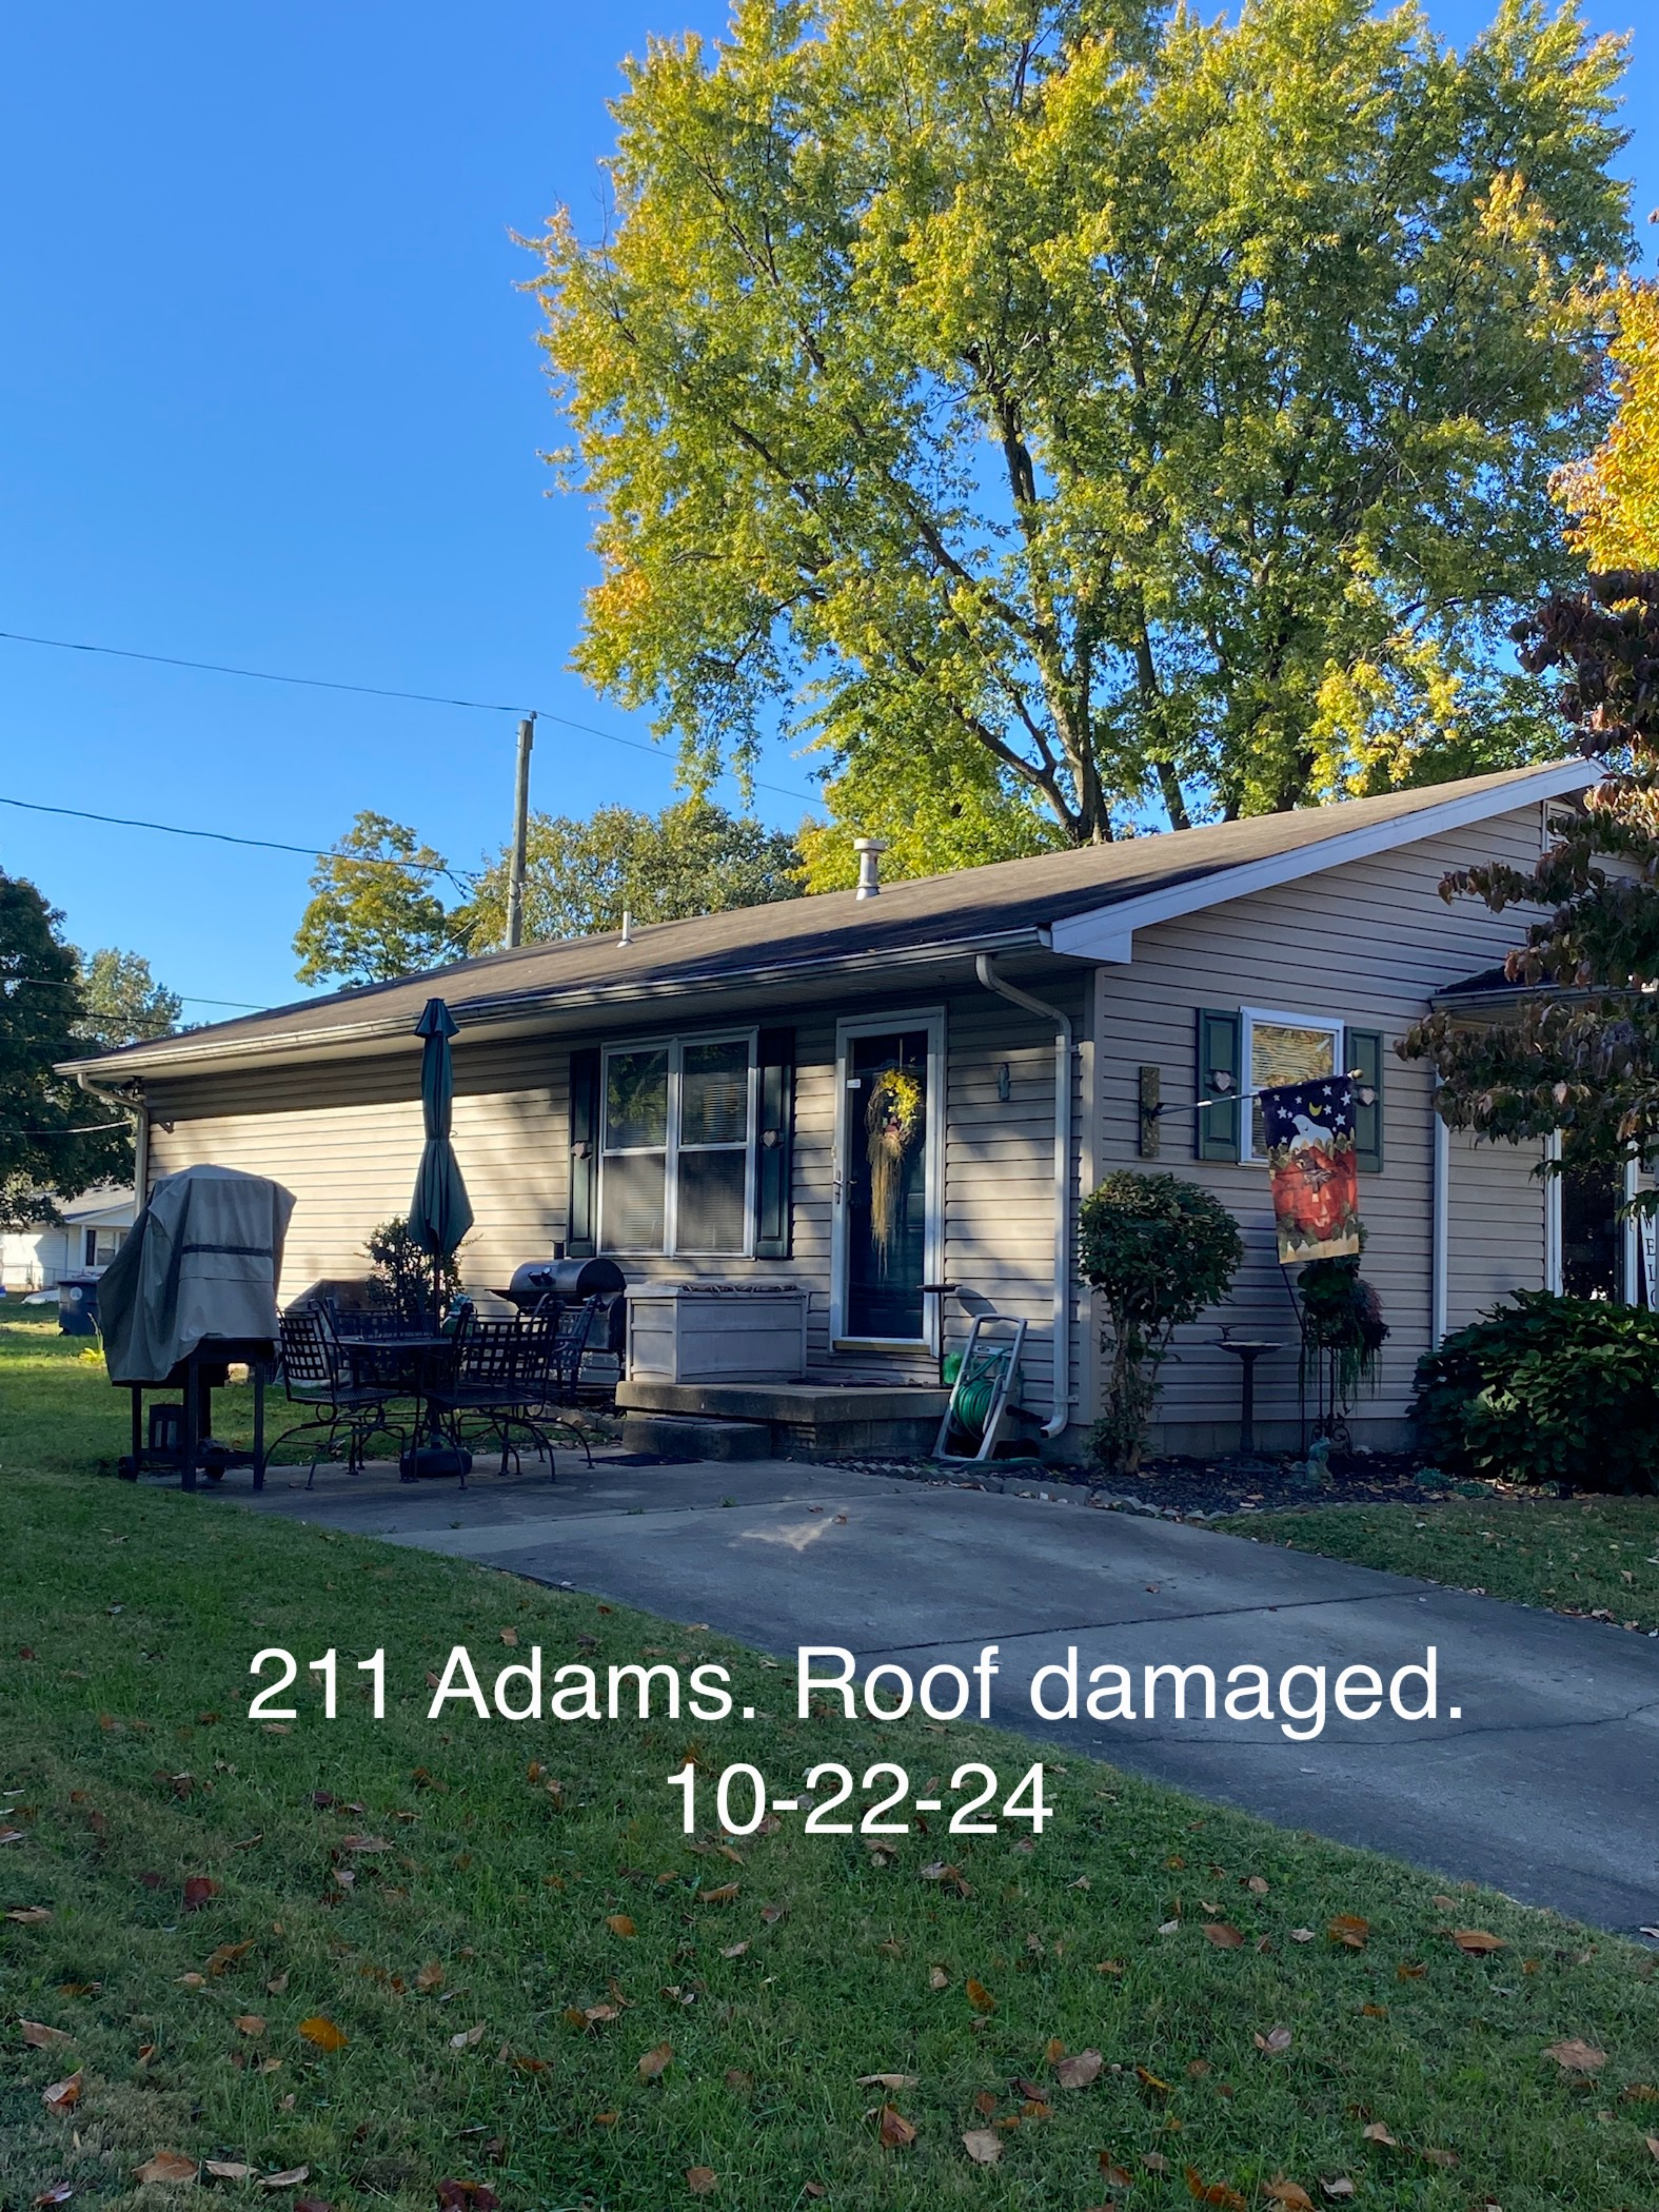
211 Adams. Roof damaged.
10-22-24

A photograph of a grey HVAC unit in a cluttered utility room. The unit is a 'Comfortmaker' brand, with a label 'N-424' and a warning label. It has a silver metal duct on top. To the left, there is a blue storage bin, a coiled green hose, and various tools like brooms and a shovel. A wooden door is on the right. The text 'HVAC intermittent. 10-22-24. 211 Adams' is overlaid in the center.

HVAC intermittent. 10-22-24.
211 Adams

2. Install a new HVAC system complete. The new Furnace & AC equipment is to be Trane or equal in quality. The new HVAC system is to heat and cool the home and sized accordingly. Include any duct work, vents, refrigerant lines and electrical that may be needed. The new outside condenser unit is to be in same location on a new pad. Include all necessary materials to complete the project.

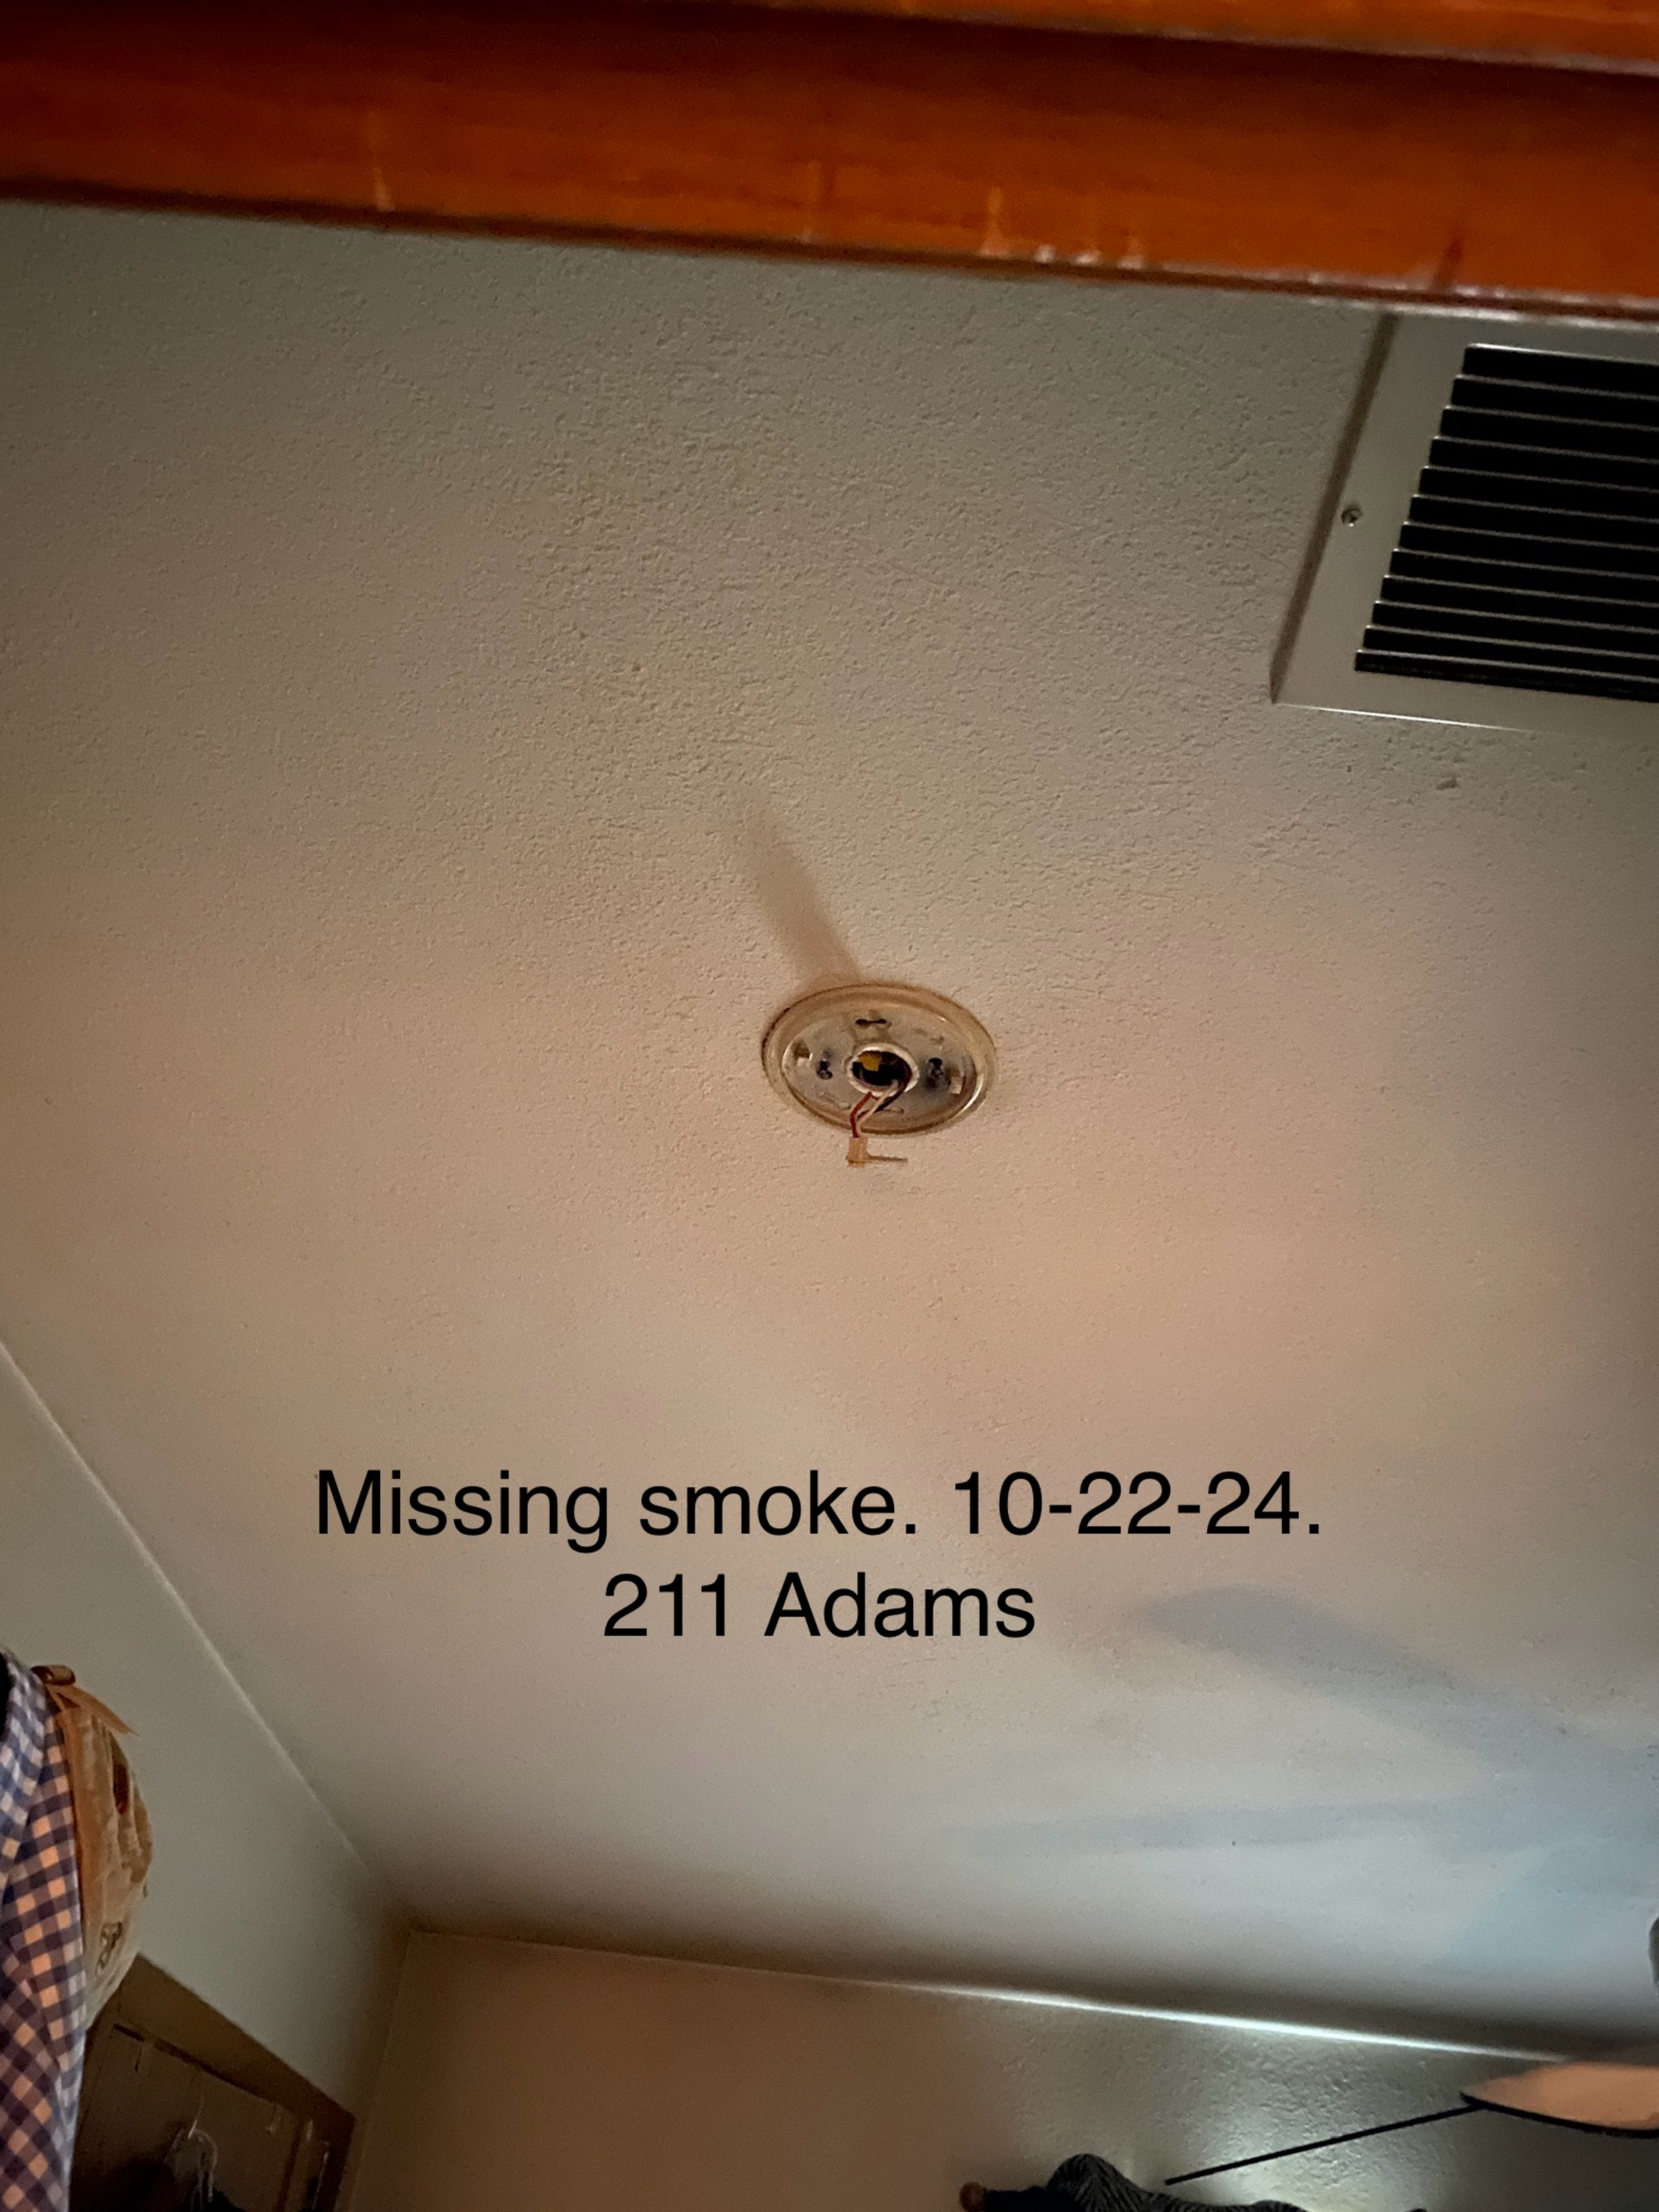
A photograph of a white, textured ceiling. In the center, there is a circular smoke detector with its cover removed, showing internal wiring. To the right, there is a rectangular air vent with black slats. The top edge of the image shows a wooden trim. The bottom left corner shows a portion of a wall with a blue and white checkered pattern. The bottom right corner shows a portion of a wall with a dark pattern.

Missing smoke. 10-22-24.
211 Adams

3. Replace the missing and nonfunctional smoke detectors throughout the home. The new detectors are to be hardwired with battery backup. Include all materials and labor to complete.

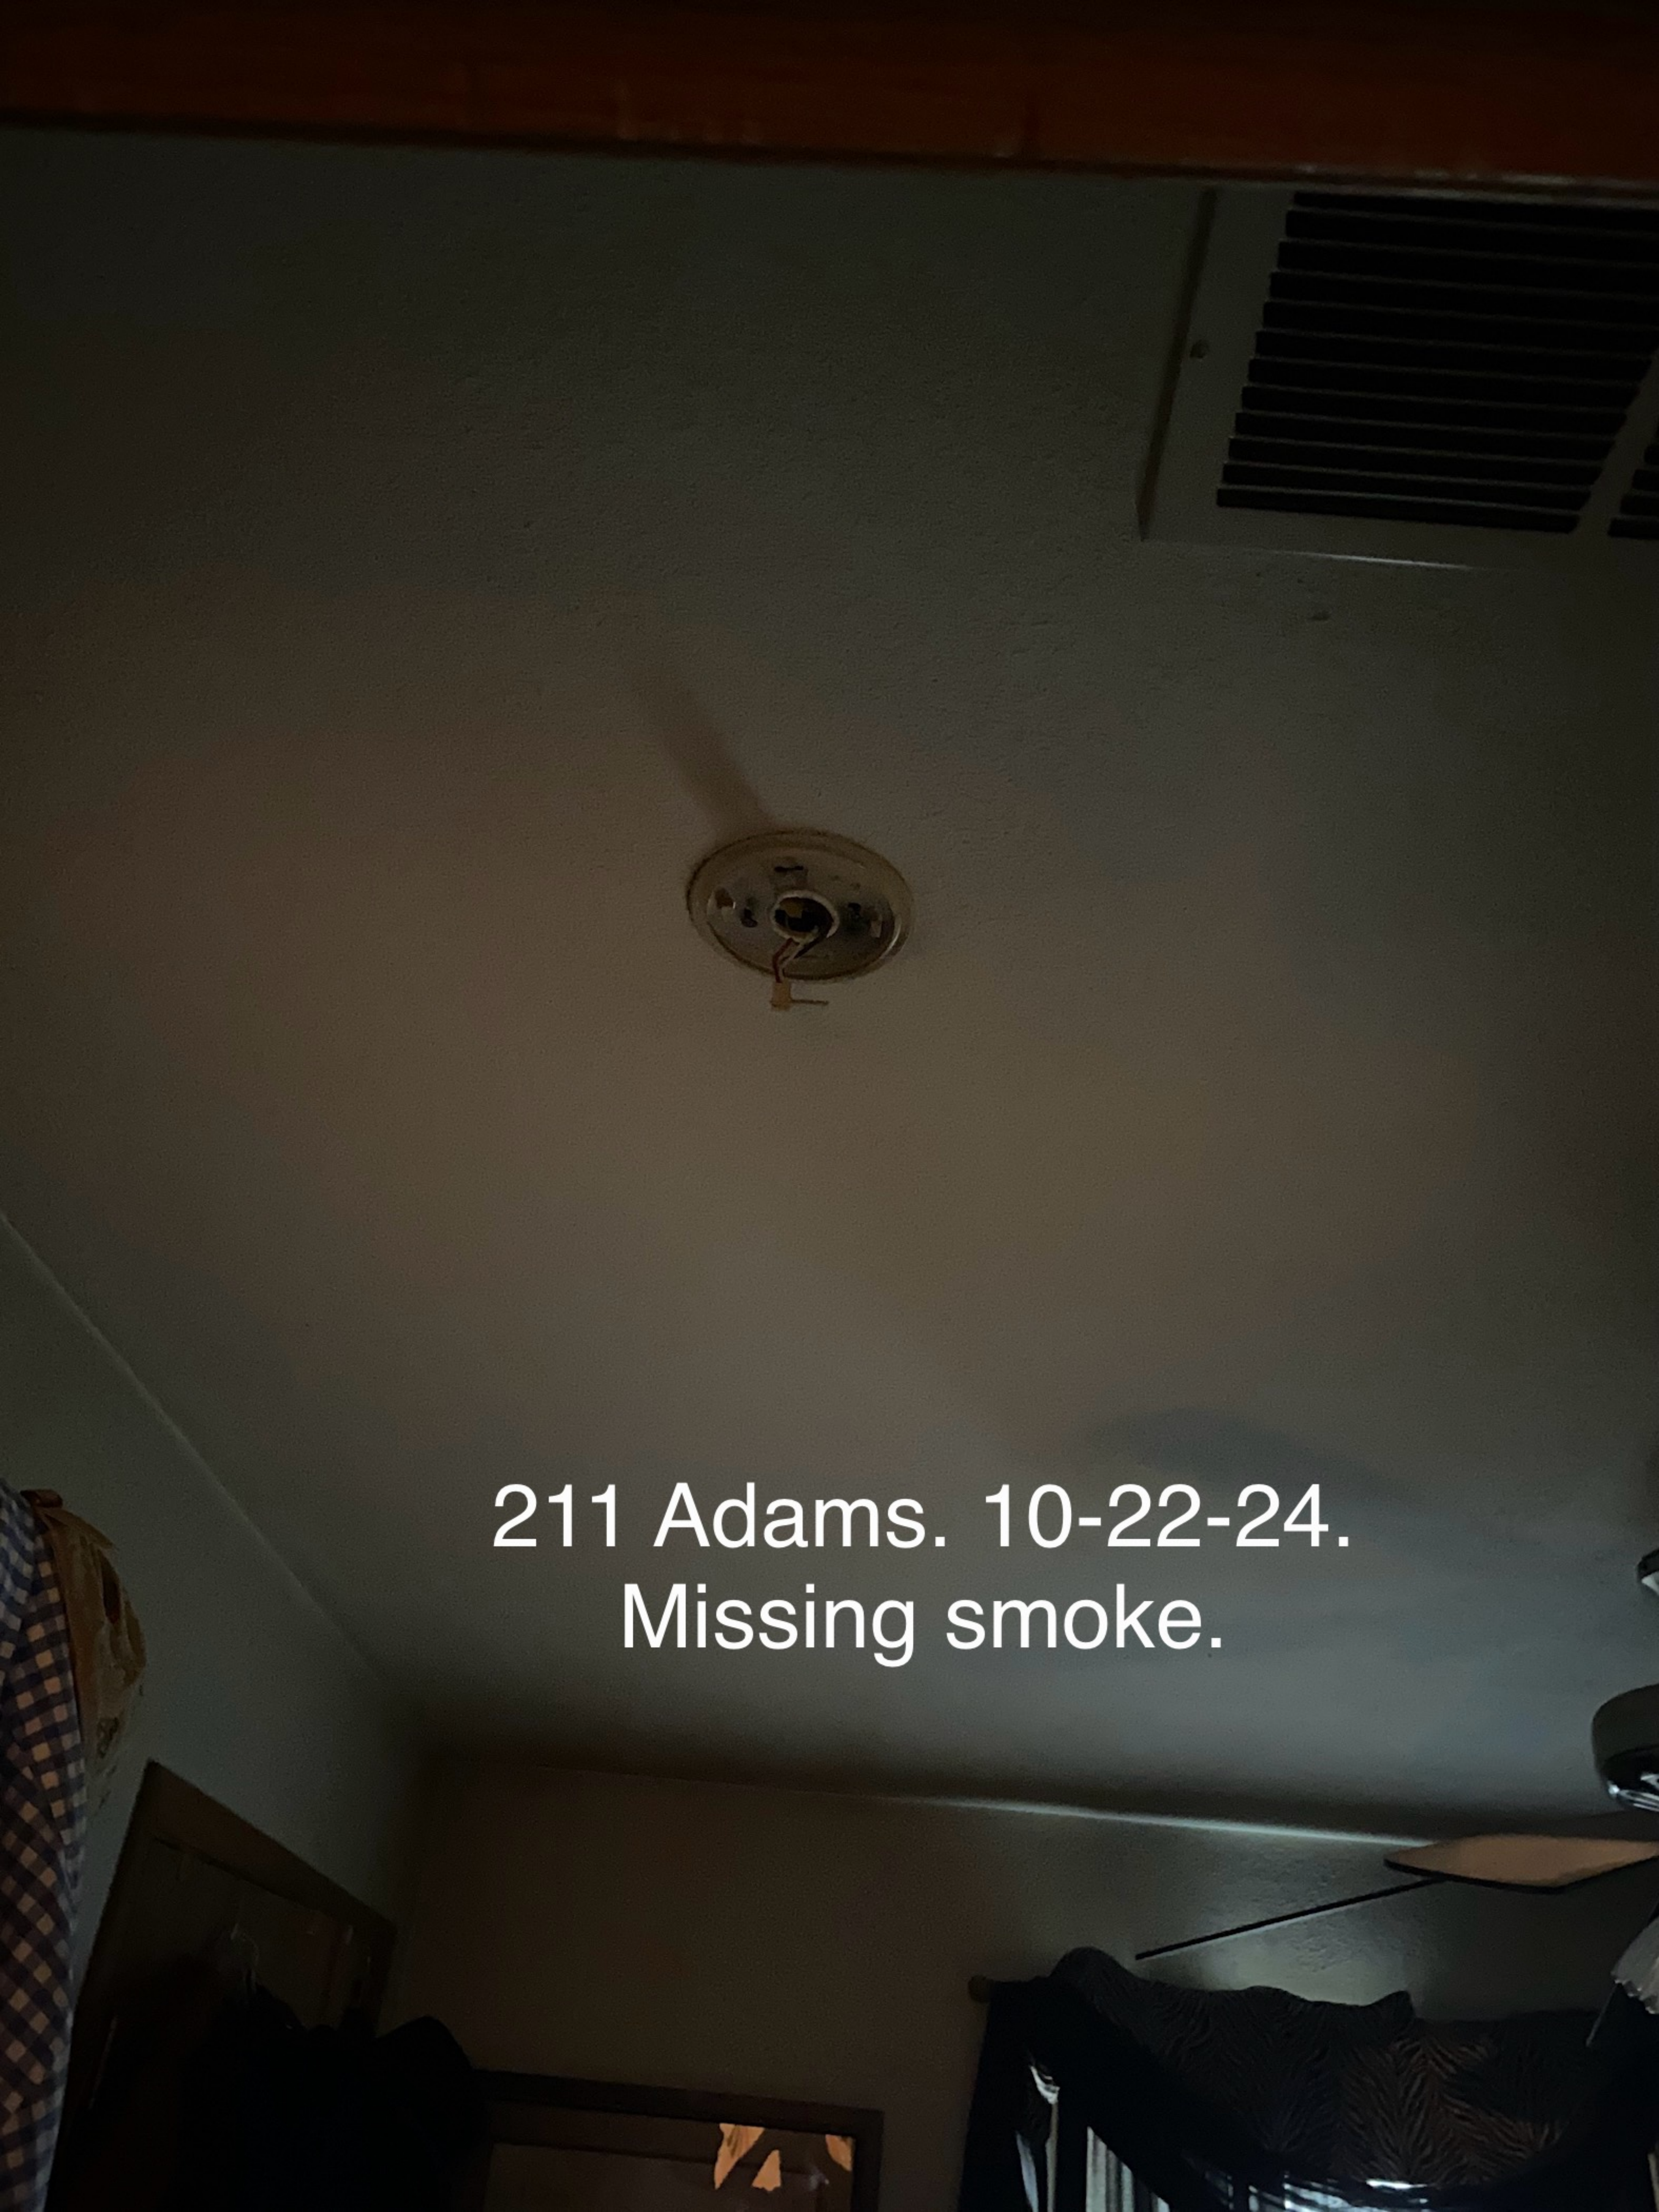
A photograph of a ceiling with a smoke detector and an air vent. The smoke detector is a circular, beige-colored device with a small red light and a small black sensor. It is mounted on a white ceiling. To the right of the smoke detector is a rectangular air vent with horizontal slats. The lighting is dim, and the overall tone is dark. The text "211 Adams. 10-22-24. Missing smoke." is overlaid on the image in white font.

211 Adams. 10-22-24.
Missing smoke.

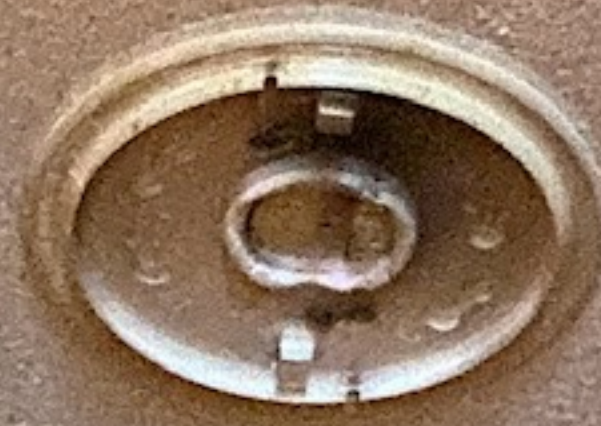
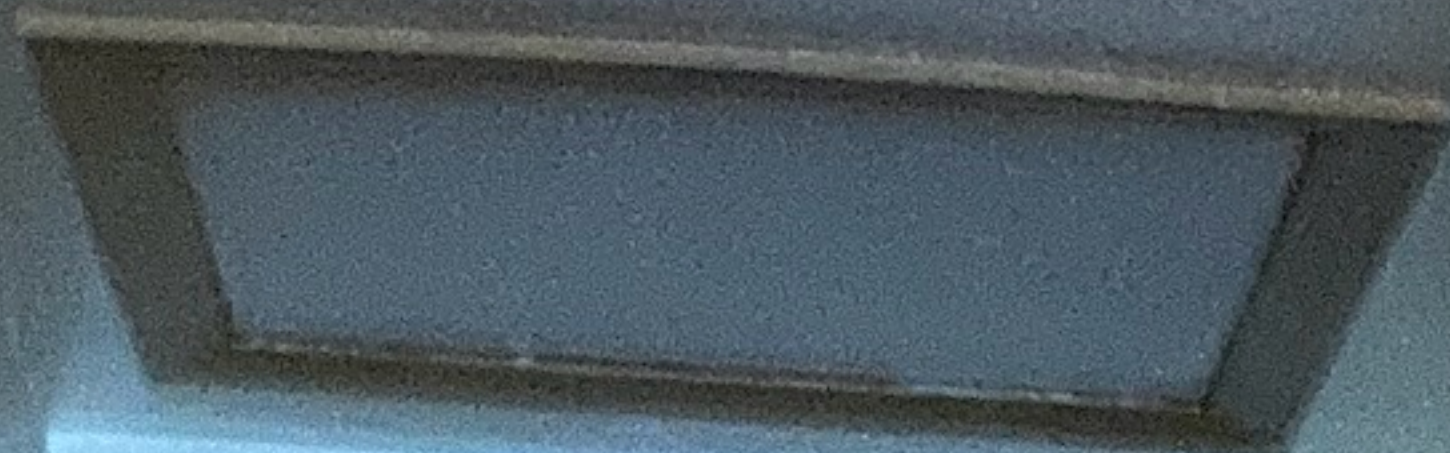
211 Adams. 10-22-24.
Missing smoke detector

211 Adams. 10-22-24.
Sidewalk trip hazard.

4. Remove the front three sections of the concrete sidewalk from the public sidewalk toward the home. Install a new section of 6" PVC sewer hard pipe to allow for drainage. Install a new concrete sidewalk to replace the removed. New concrete finish is to match existing as close as possible. Haul away all debris when completed. Provide all necessary material to complete.
