CRANE
ENVIRONMENTAL SERVICES, LLC

April 20, 2018

RE: Asbestos Building Inspection for 2120 W. Delaware St, Evansville, Indiana – Crane Project #118-2011

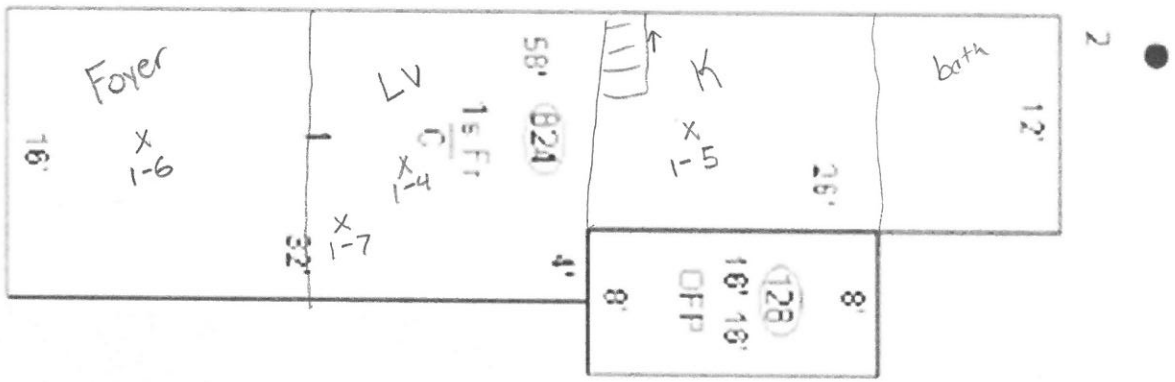
First Floor

DATE	SAMPLE #	MATERIAL SAMPLED	LOCATION	Notes
		SVF	K, bath	11x12, 10x11
	1-7	DW	LV closet	3 sq 2' 3 wraps
	1-4	LP	LV	
	1-5	HP	K	Dup-1
	1-6	HP	Foyer	
		VAT	R1	9"x 9" tile, 11x13
	2-1	DT	Attic	4LF. 4vents
