Form Name: **IHCDA | BLN Pre-Bid Survey Results**
 Submission Date: Apr 22, 2019 12:26:27 PM EDT

Date of Survey Apr 22, 2019
 Name of Surveyor Larry McIntire
 Applicant Name City of Evansville
 Property Address 304 East Virginia Street, Evansville, Indiana 47711

Date of Survey Apr 22, 2019
 Name of Surveyor Larry McIntire
 Applicant Name City of Evansville
 Property Address 319 Read Street, Evansville, Indiana 47710

Date of Survey Apr 22, 2019
 Name of Surveyor Larry McIntire
 Applicant Name City of Evansville
 Property Address 701 North 10th Avenue, Evansville, Indiana 47712

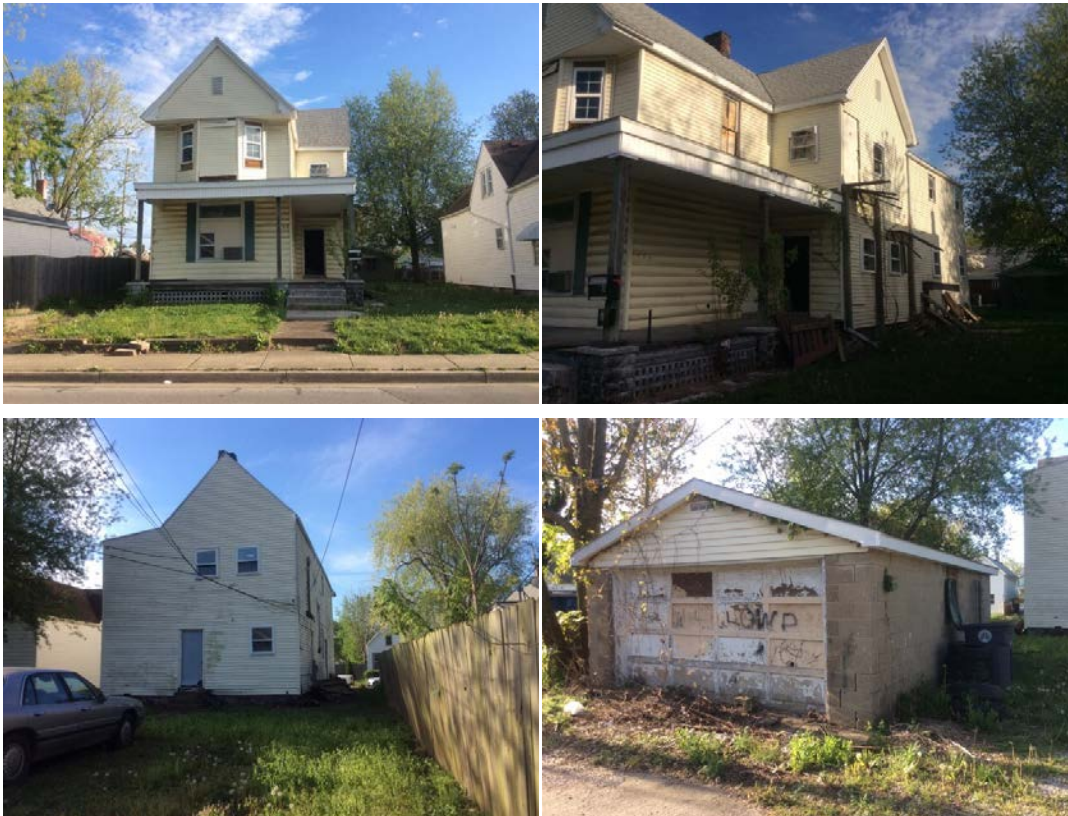
Image of Property

Surveyor Comments	House is two story wood frame on brick cellar with vinyl siding. House has been stripped internally and is mostly clear on main level. Could not access cellar or second level due to collapsed stairs. Cellar looks to have some trash in it. There are tile floors in some rooms. There is a block detached garage in back which could not be accessed. The house has concrete walks around the outside and concrete steps. There is a small retaining wall in front with a concrete drive. Yard is
-------------------	---

mostly clear with some debris from collapsed exterior stairs.
